Mount Barker Flood Mapping Study

## STUDY REPORT

### District Council of Mount Barker

January 2011

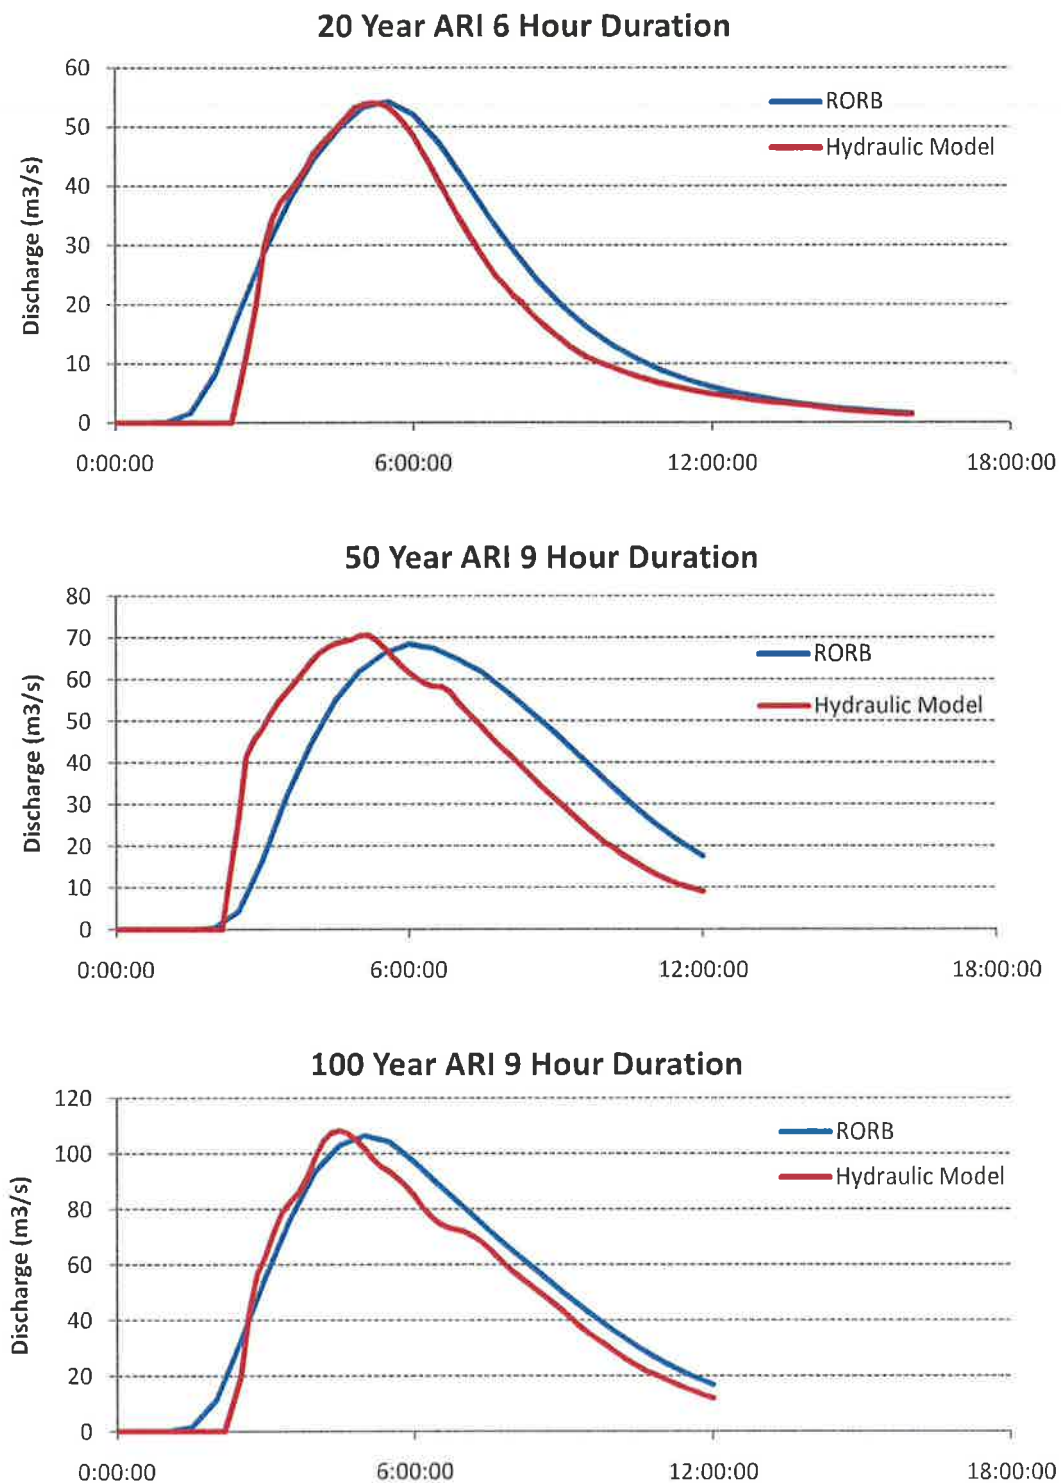
FIGURE 4.5: COMPARISON OF RORB AND HYDRAULIC MODEL HYDROGRAPHS AT MODEL OUTLET

A comparison of hydrograph shapes for each ARI event is given in the Figure 4.5 below

The peak flows at the hydraulic model outlet corresponded well with RORB flow estimates at the same location. The peaks from the hydraulic model were generally within 3% of the RORB peak flows over the range of design events. The hydrograph shape at the hydraulic model outlet was also found to be consistent with the RORB hydrograph. Hydrograph volumes tended to be slightly less in the model compared to the RORB outputs.

The Mount Barker catchment is steep with little flood storage capacity, and floods tend to be flashy as a result of this. Peak flow is usually more important than hydrograph volume for determining flood inundation, depth and hazard under this sort of regime. The close correspondence between the modelled peak flow and the RORB peak flow at the outlet indicates that the model will provide a good estimate of peak flood depth and hazard.

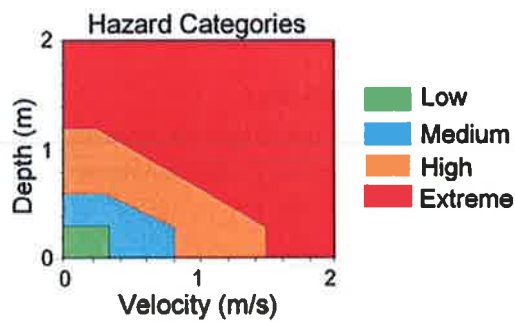
FIGURE 4.6: FLOOD HAZARD RATINGS (ADAPTED FROM SCARM 2000)

Furthermore, hazard to people, animals and property will be increased if water is flowing fast rather than slow. Research has determined safety thresholds for movement of small children through flowing waters which is considered a key aspect of hazard definition in terms of safe evacuation from flood effected areas. Flood hazard mapping introduces the effects of velocity and effectively links the combined threats posed by depth of water and flow velocity. Figure 4.6 below illustrates the adopted flood hazard rating system (based on SCARM, 2000).

As illustrated by Figure 4.6 if floodwater is deep it may create a serious hazard. Similarly, water flowing with high velocity, even at a shallow depth, may present a similar hazard.

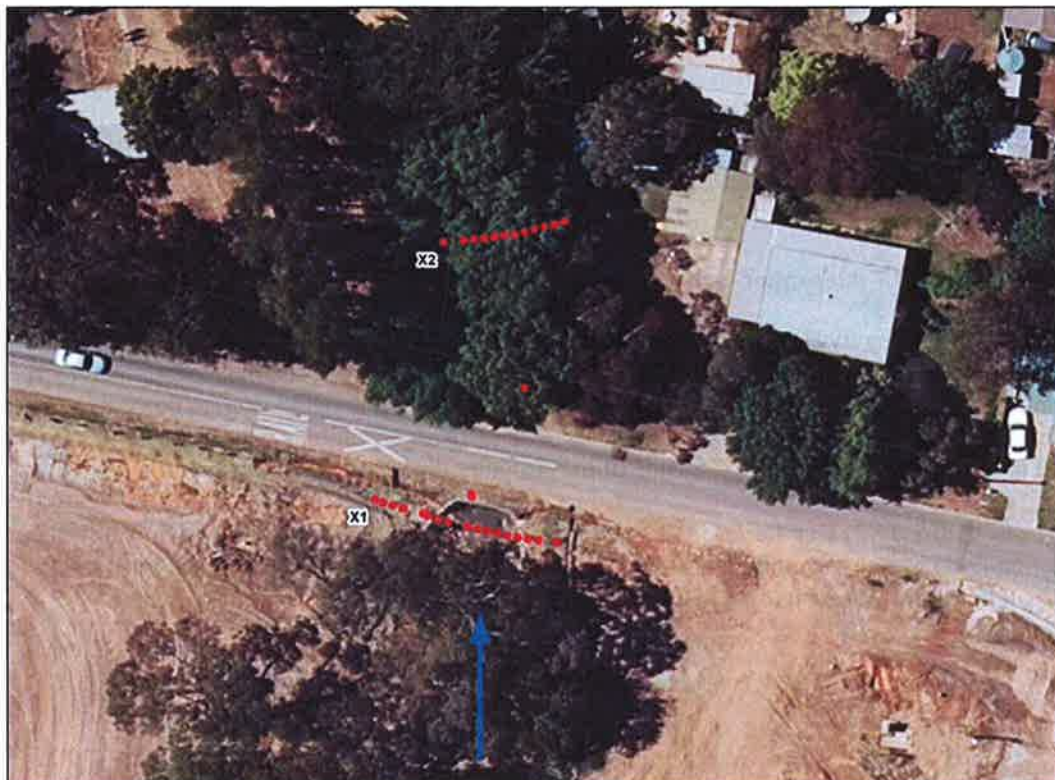
Figure 3: Cross section X1 and X2; Hurling Drive

A cross section (X1) was surveyed 2m upstream of the structure. Downstream, a cross section (X2) was surveyed 16m from the culvert. The surveyed cross sections for X1 and X2 are shown in Figure 4 and Figure 5 respectively.

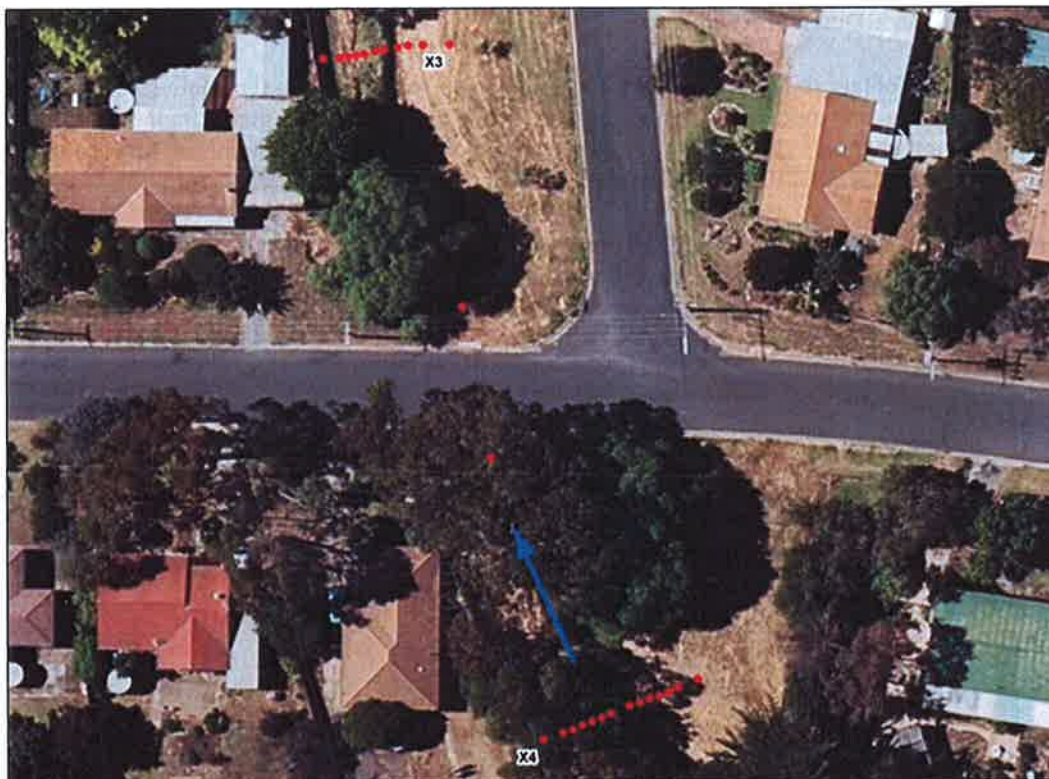
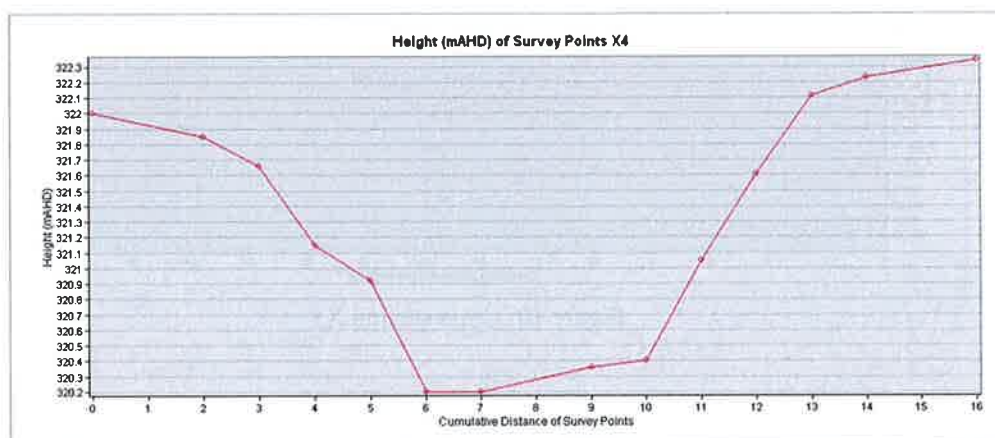
Figure 6: Cross section X3 and X4; Alexander Drive

A cross section (X3) was surveyed downstream of the Alexander Drive culvert while a further cross section (X4) was surveyed 27m upstream of the culvert. The surveyed cross sections for X3 and X4 are shown in Figure 7 and Figure 8 respectively.

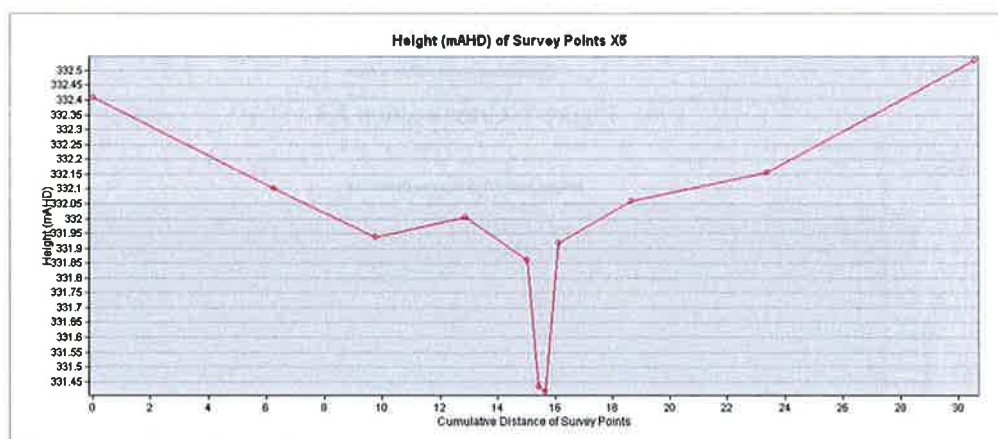
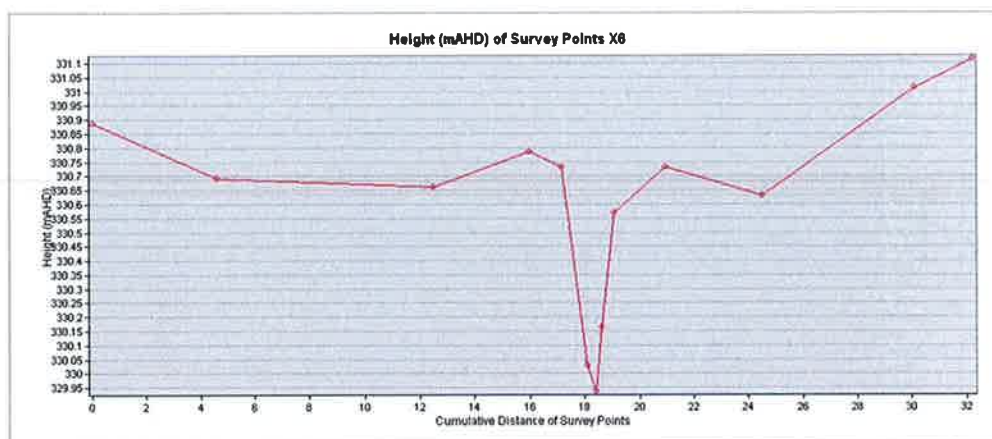
Figure 9: Cross section X5 and X6; Duffield Avenue

A cross section (X5) was surveyed 19m upstream of Duffield Avenue while a further cross section (X6) was surveyed 25m downstream of the culvert. The surveyed cross sections for X5 and X6 are shown in Figure 10 and Figure 11 respectively.

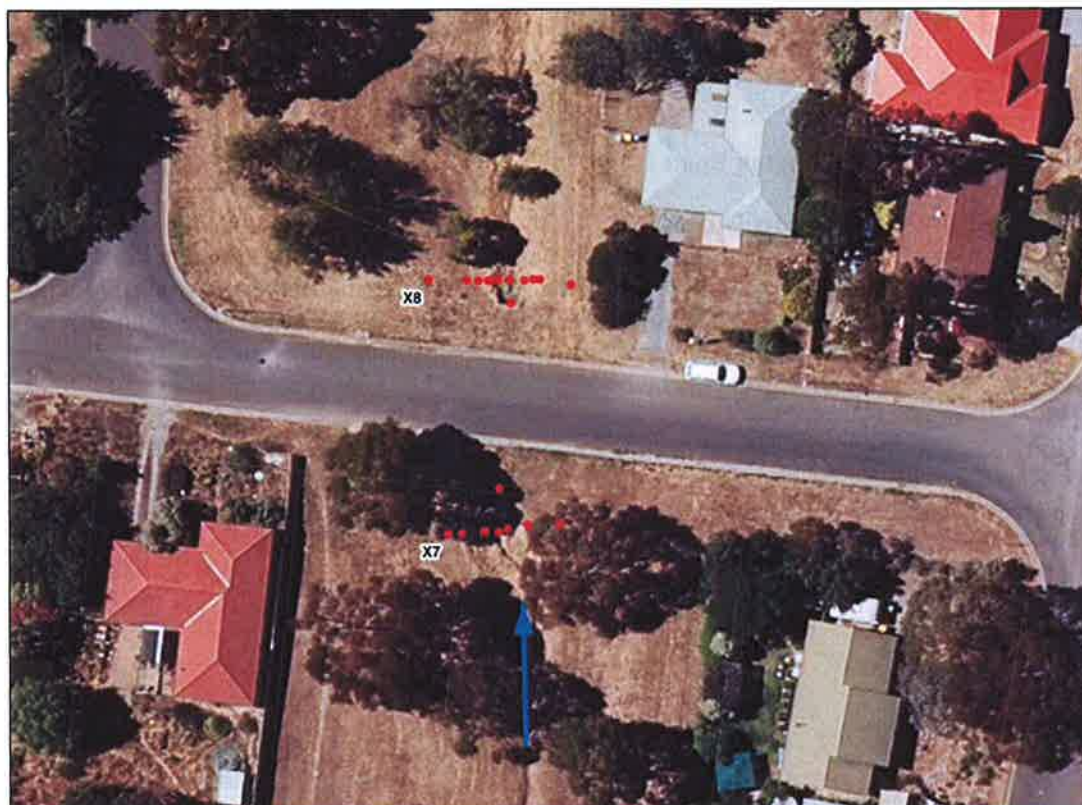
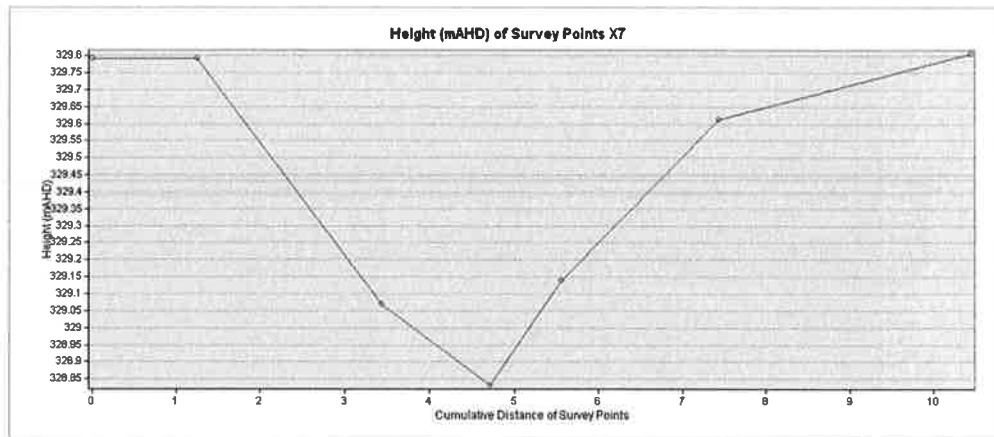
Figure 12: Cross section X7 and X8; Acacia Street

A cross section (X7) was surveyed 4m upstream of Acacia Street while a further cross section (X8) was surveyed 2m downstream of the culvert. The surveyed cross sections for X7 and X8 are shown in Figure 13 and Figure 14 respectively.

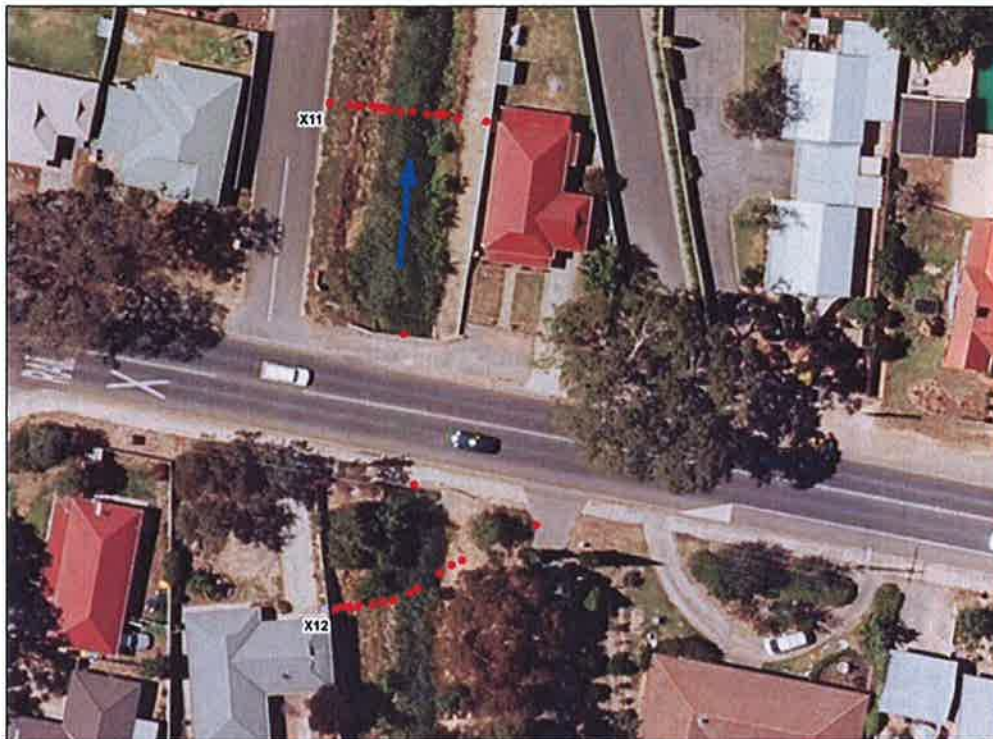
Figure 18: Cross section X11 and X12; Alexandrina Road

A cross section (X11) was surveyed 23m downstream of Alexandrina Road while a further cross section (X12) was surveyed 11m upstream of the culvert. The surveyed cross sections for X11 and X12 are shown in Figure 19 and Figure 20 respectively.

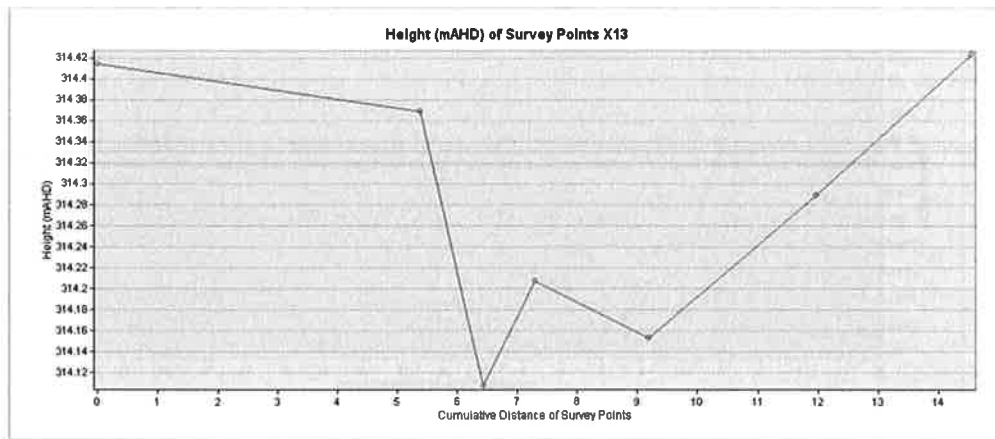
Figure 21: Cross section X13 and X14; Alexandrina Road

A cross section (X13) was surveyed 5m downstream of Alexandrina Road while a further cross section (X14) was surveyed 8m upstream of the culvert. The surveyed cross sections for X13 and X14 are shown in Figure 22 and Figure 23 respectively.

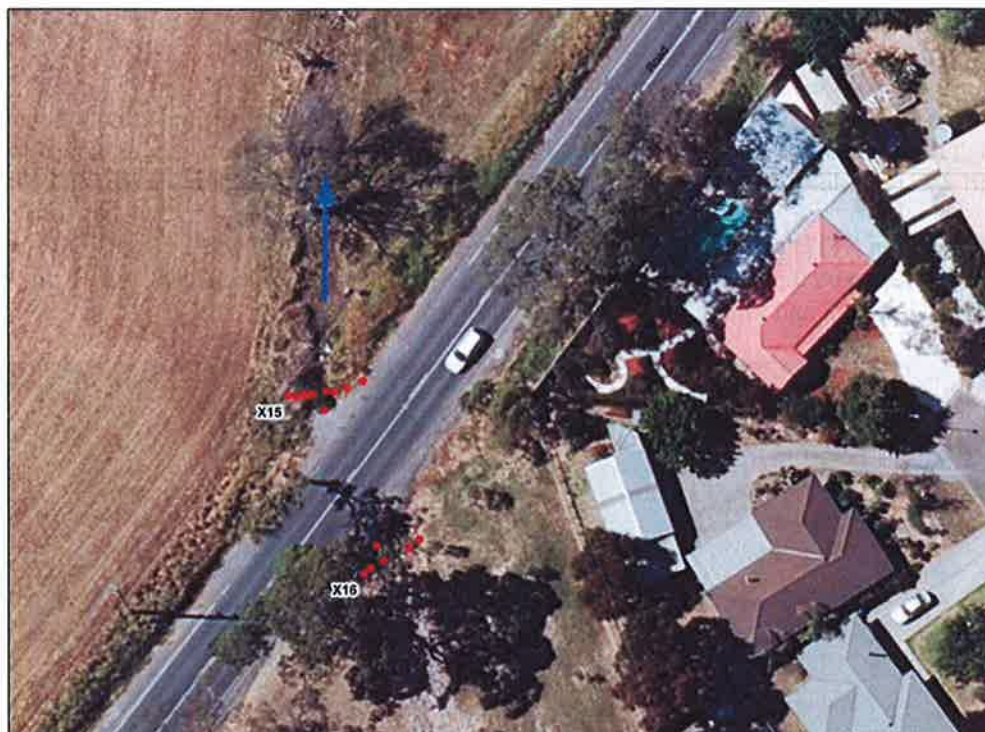
Figure 24: Cross section X15 and X16; Flaxley Road

A cross section (X15) was surveyed 2m downstream of Flaxley Road while a further cross section (X16) was surveyed 2m upstream of the culvert. The surveyed cross sections for X15 and X16 are shown in Figure 25 and Figure 26 respectively.

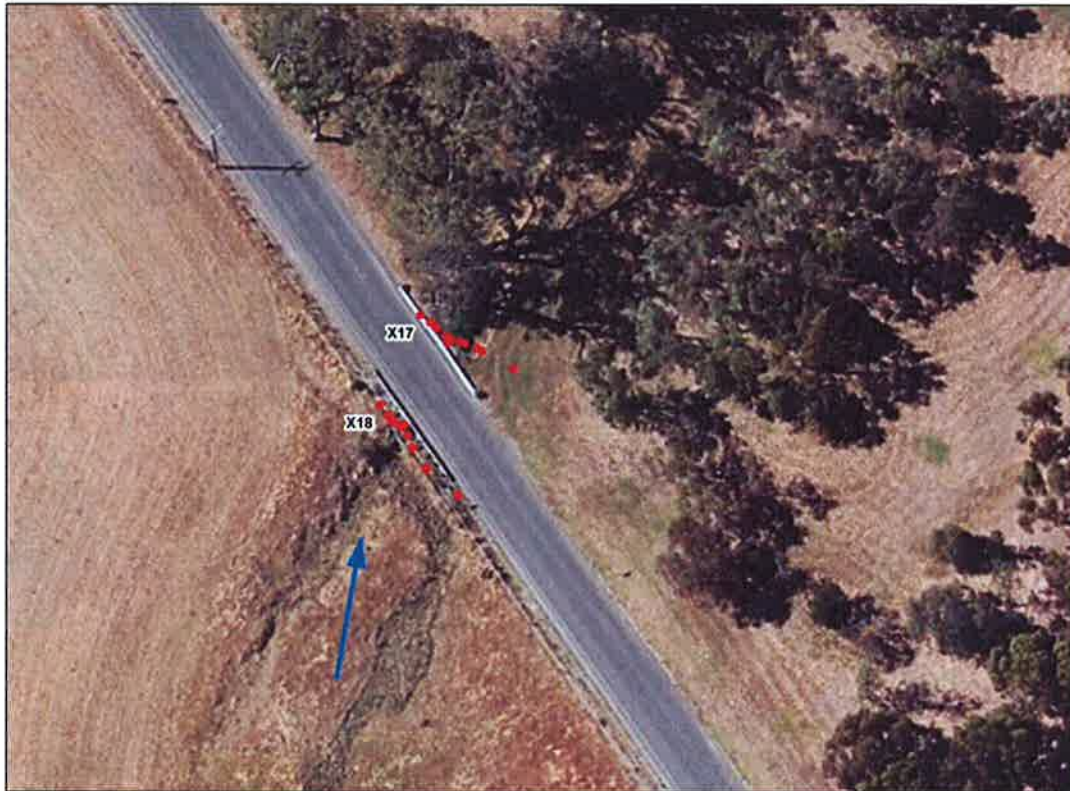
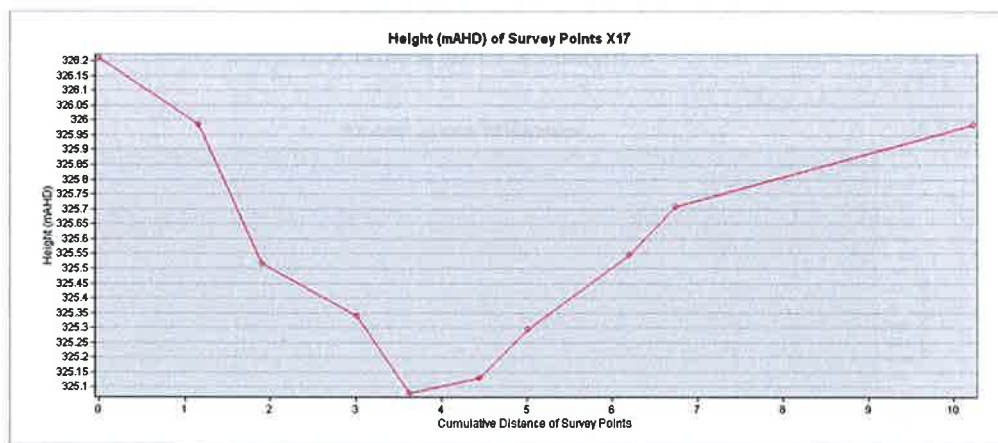
Figure 27: Cross section X17 and X18; Bollen Road

A cross section (X17) was surveyed 0.5m downstream of Bollen Road while a further cross section (X18) was surveyed 0.5m upstream of the culvert. The surveyed cross sections for X15 and X16 are shown in Figure 28 and Figure 29 respectively.

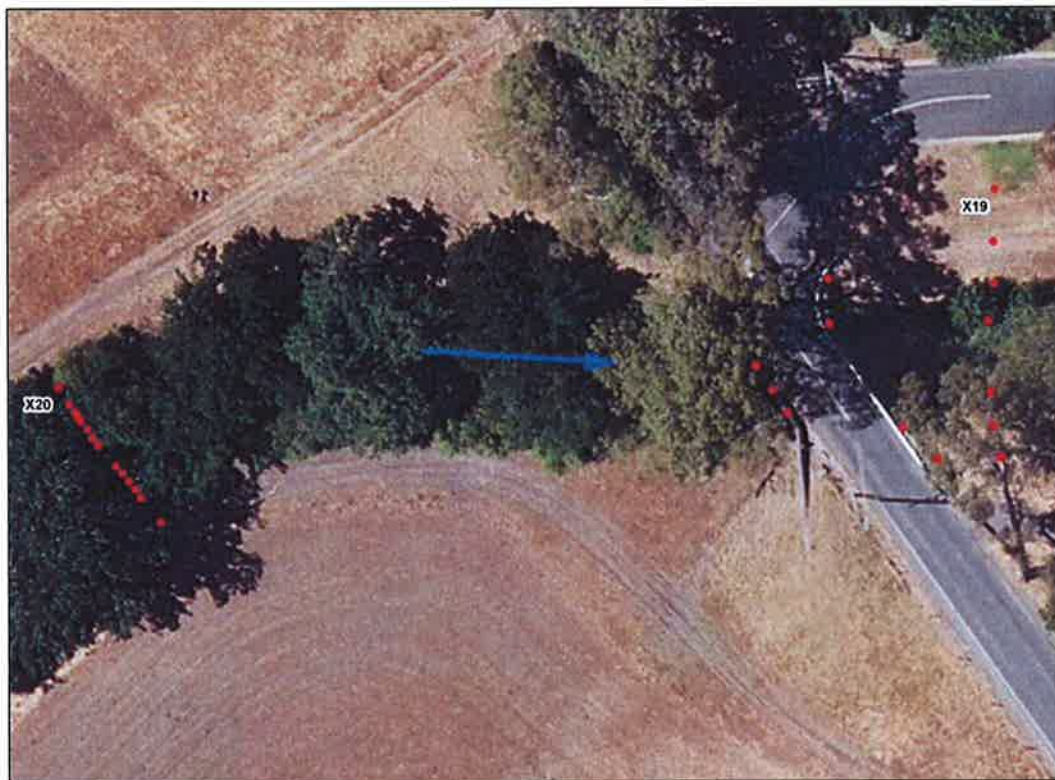
Figure 30: Cross section X19 and X20; Bollen Road

A cross section (X19) was surveyed 14m downstream of Bollen Road while a further cross section (X20) was surveyed 67m upstream of the culvert. The surveyed cross sections for X19 and X20 are shown in Figure 31 and Figure 32 respectively.

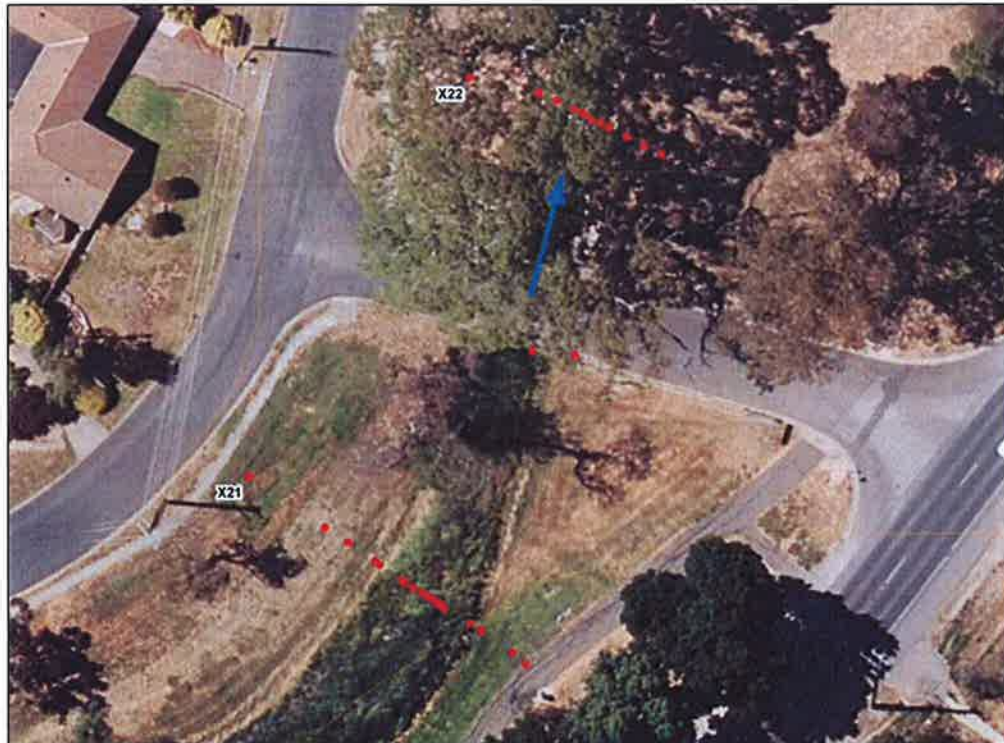
Figure 33: Cross section X21 and X22; Kay Road

A cross section (X21) was surveyed 27m upstream of Kay Road while a further cross section (X22) was surveyed 15m downstream of the culvert. The surveyed cross sections for X21 and X22 are shown in Figure 34 and Figure 35 respectively.

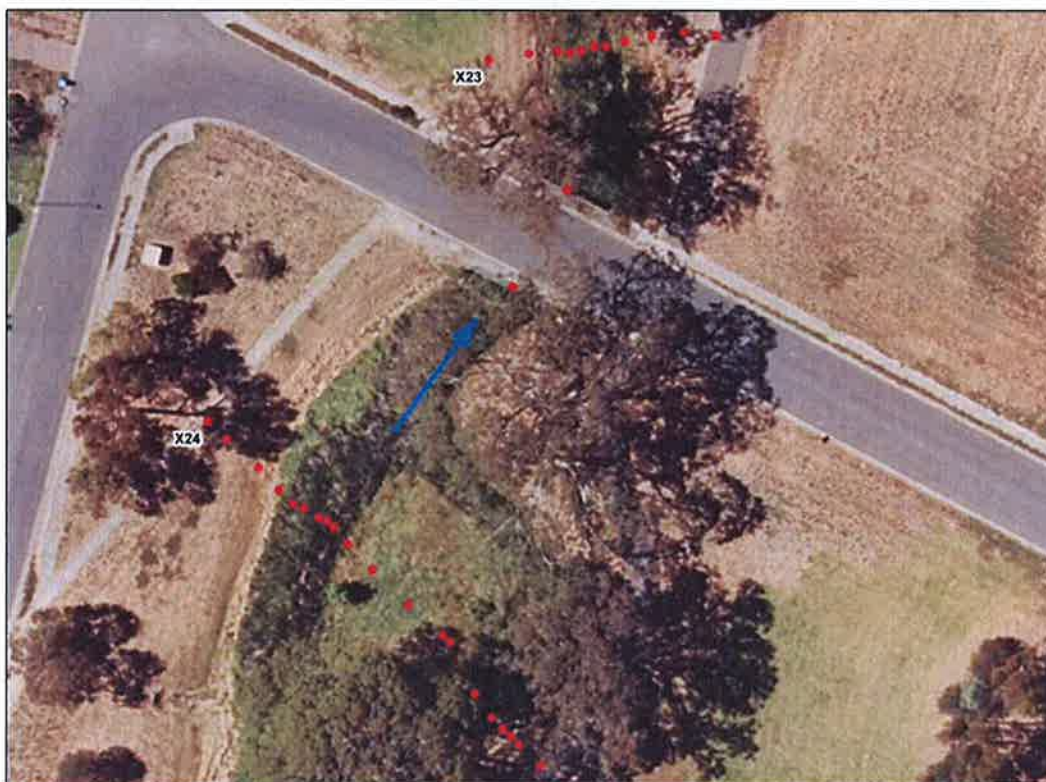
Figure 36: Cross section X23 and X24; May Road

A cross section (X23) was surveyed 15m downstream of May Road while a further cross section (X24) was surveyed 30m upstream of the culvert. The surveyed cross sections for X23 and X24 are shown in Figure 37 and Figure 38 respectively.

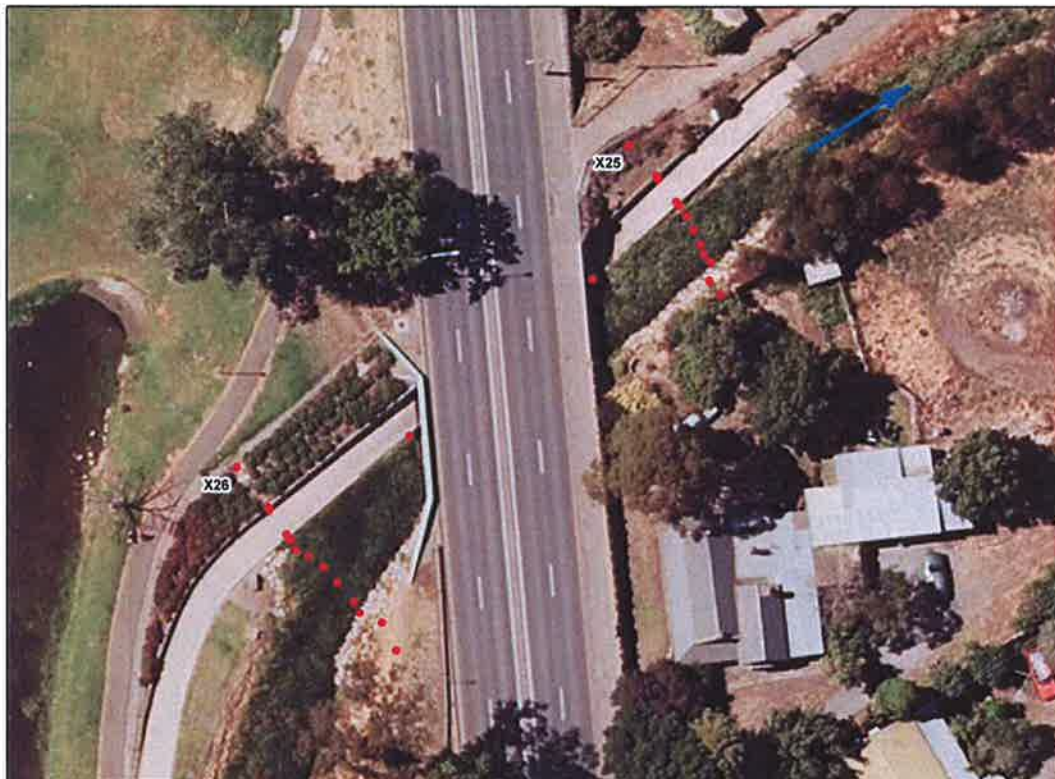
Figure 39: Cross section X25 and X26; Adelaide Road

A cross section (X25) was surveyed 11m downstream of Adelaide Road while a further cross section (X26) was surveyed 15m upstream of the culvert. The surveyed cross sections for X25 and X26 are shown in Figure 40 and Figure 41 respectively.

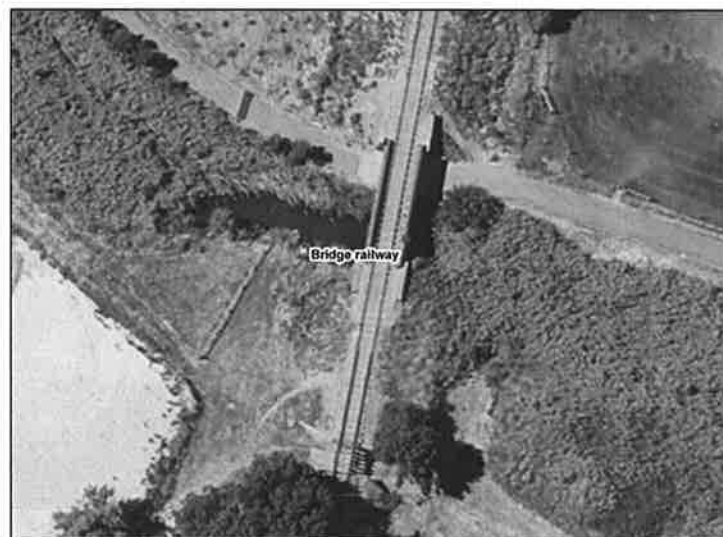
Figure 42: Bridge; Railway

The railway bridge on Mount Barker Creek is located just downstream of the junction with Western Flat Creek (see Figure 42). The watercourse is a natural open channel. The structure is a railway bridge and abutment having the dimensions of 21100mm wide and 4780mm high. Top of the sleepers is 314.59mAHD. The natural surface elevation is 309.81m.

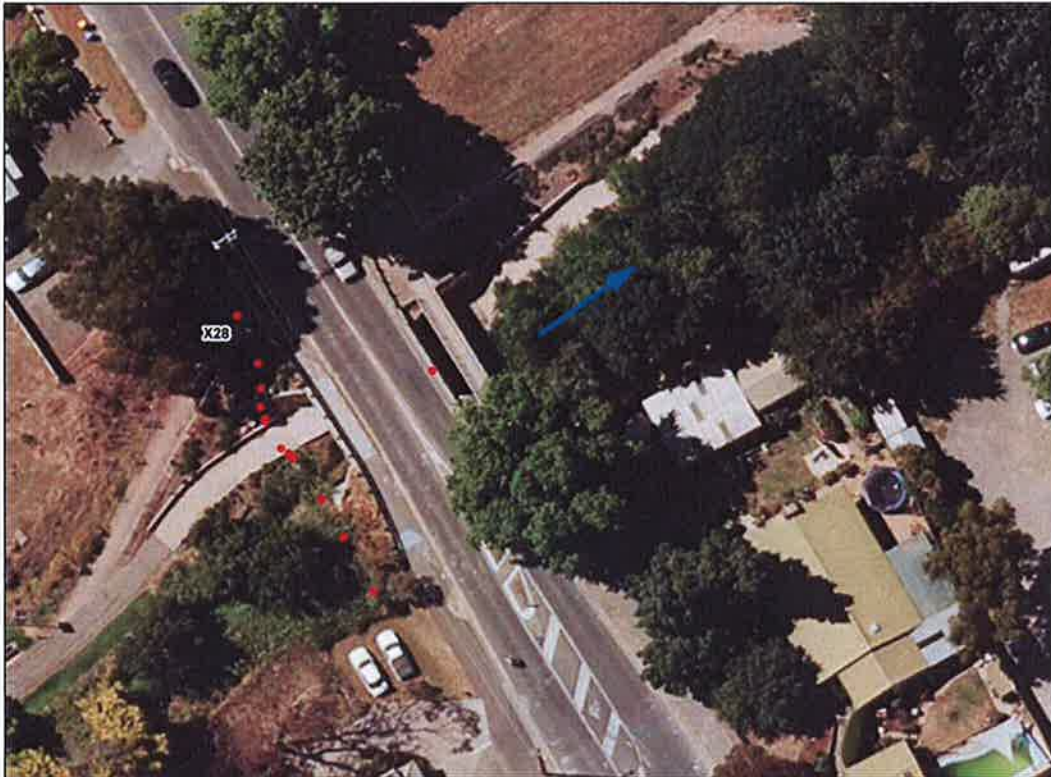
Figure 45: Cross section X28; Hutchinson Street

The surveyed cross section (X28) was taken 5m upstream of the bridge is shown in Figure 46. The elevations from distance 15 to 30 are approximate. The actual cross-sectional general shape is similar to X25 (see Fig 40).

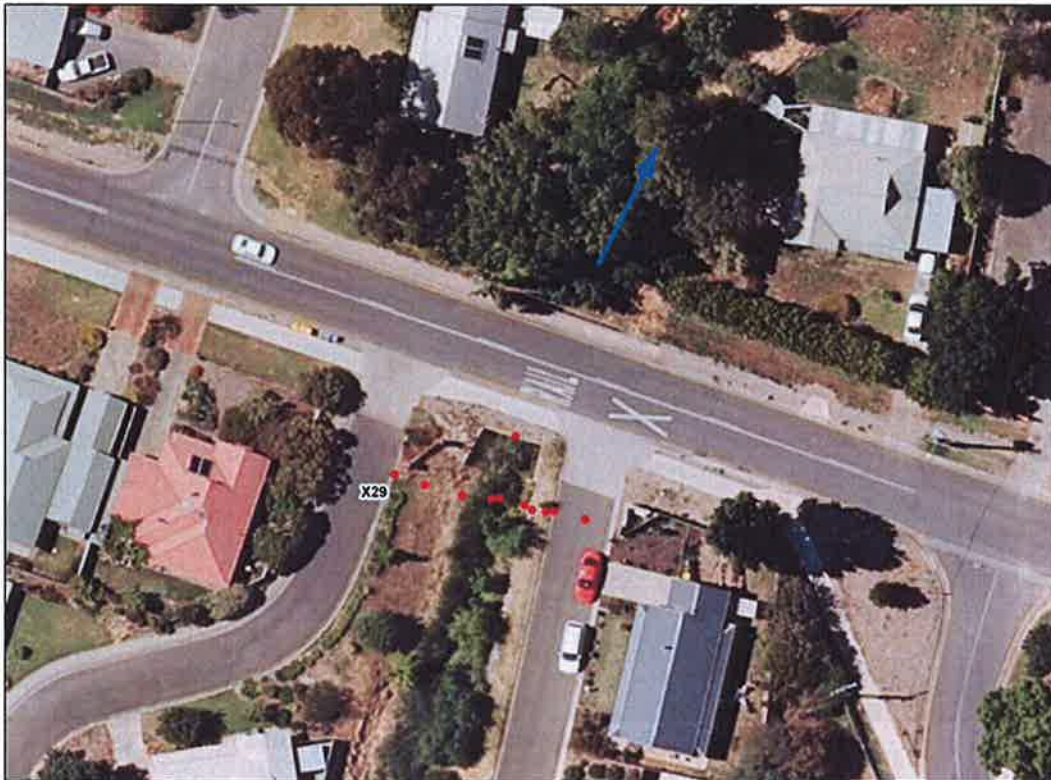
Figure 47: Cross section X29; Fletcher Road

A cross section (X29) was recorded 6m upstream of the culvert and is shown in Figure 48.

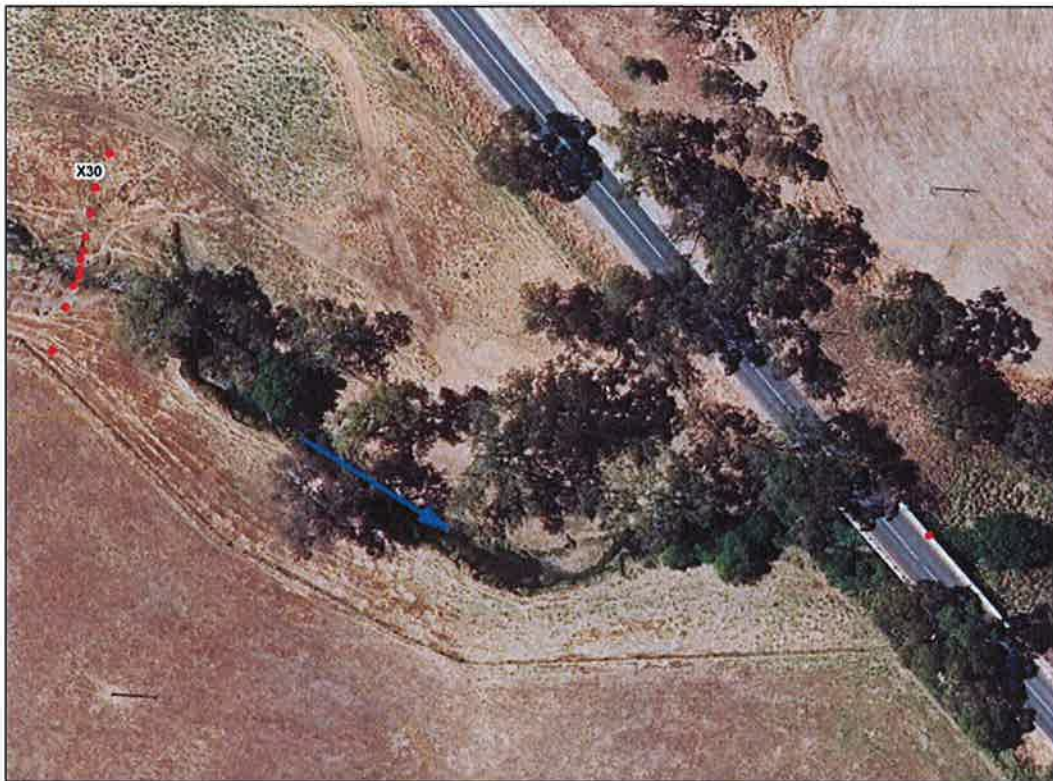
Figure 49: Cross section X30; Springs Road

A cross section (X30) was surveyed 157m upstream of the bridge and is shown Figure 50.

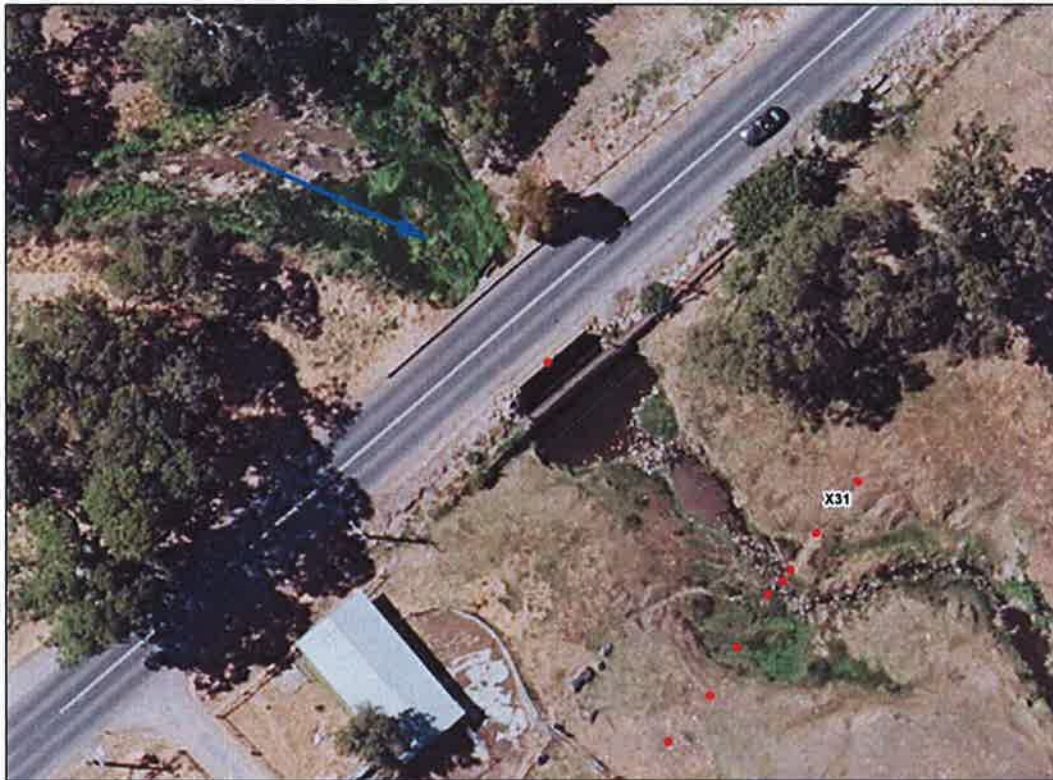
Figure 51: Cross section X31; Bald Hills Road

A cross section (X31) was taken 31m upstream of Bald Hills Road and is shown in Figure 52.

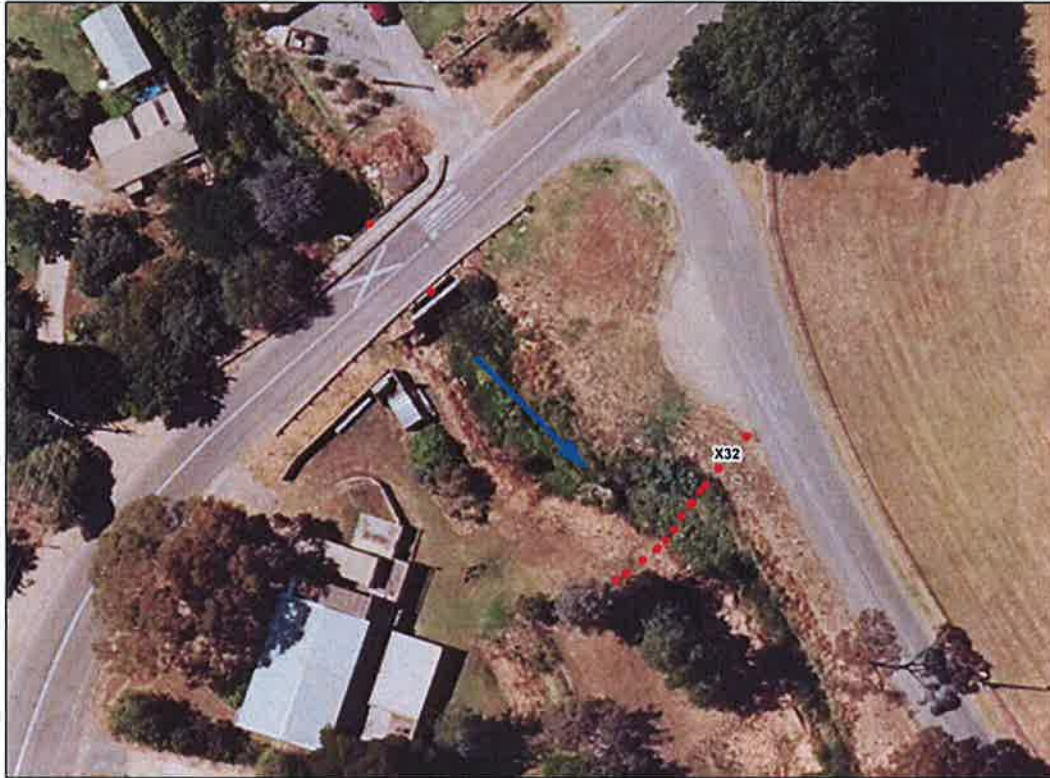
Figure 53: Cross section X32; Cameron Road

A cross section (X32) was surveyed 33m downstream from the culvert and is shown in Figure 54.

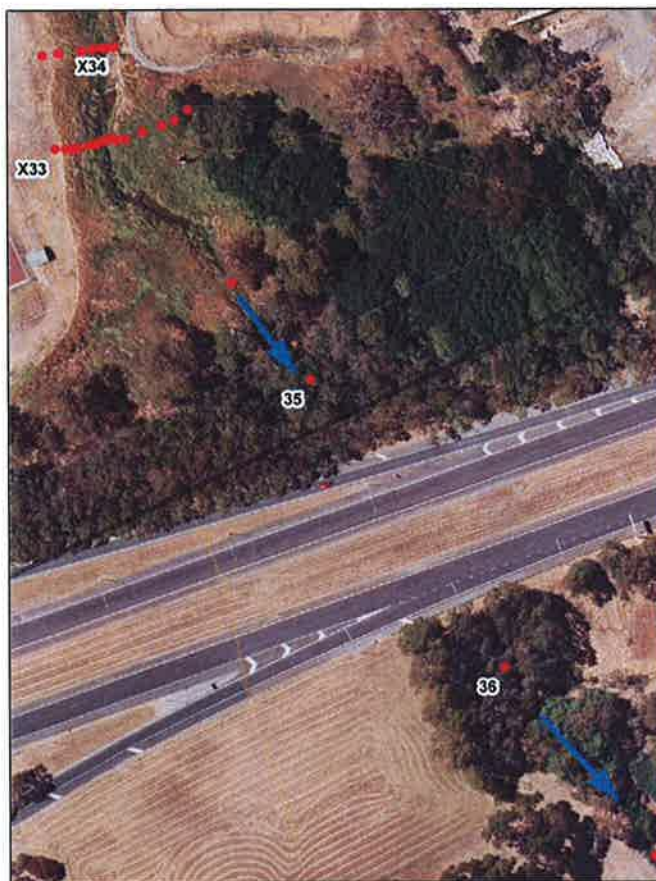
Figure 55: Cross section X33 and X34 (35, 36); S. E. Freeway

Two (2) cross sections (X33 and X34) were surveyed 99m and 130m upstream of the culvert respectively. These cross sections are shown as Figure 56 and Figure 57. At site X34 there is a constructed concrete weir with a rectangular notch.

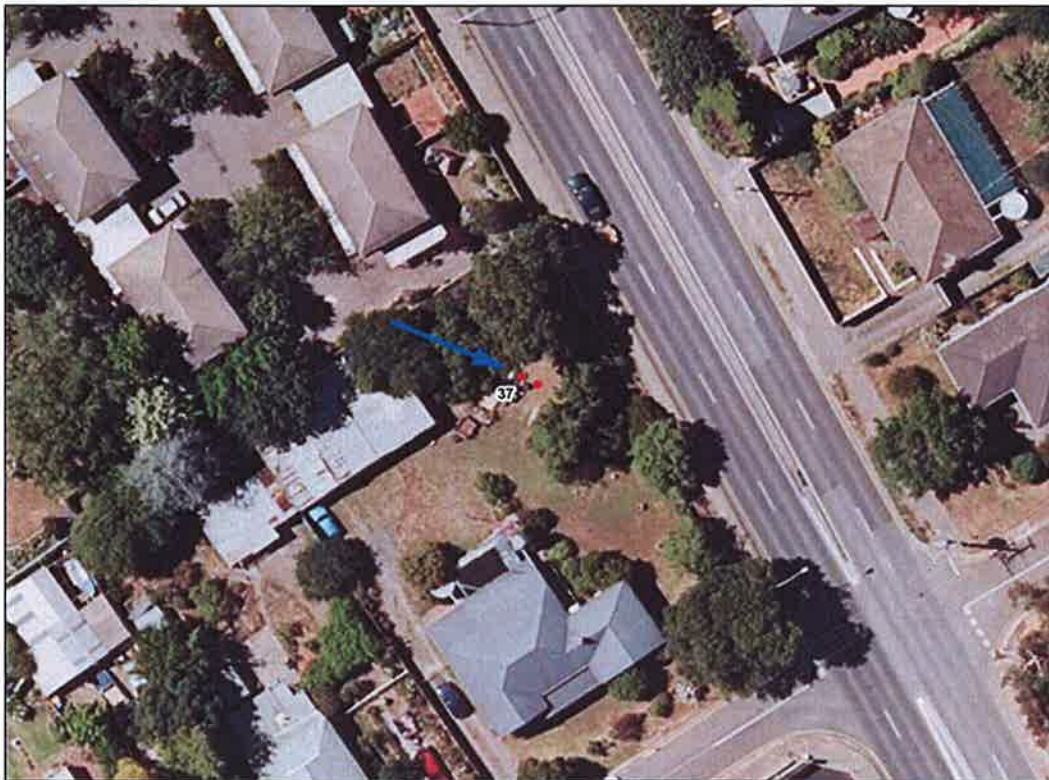
Figure 58; Inlet 37- Adelaide Road

The final survey location was where the local channel is directed into an underground drainage system along Adelaide Road (see Figure 58). The dimensions of the culvert are 2150mm wide and 900mm high. The invert elevation at the upstream end of the pipe is 335.42m. Natural surface elevation at top of inlet is 336.72m.
