Watercourse Management Plan for Mount Barker

A Report to the Mount Barker District Council

Miles Environmental Pty Ltd

2019

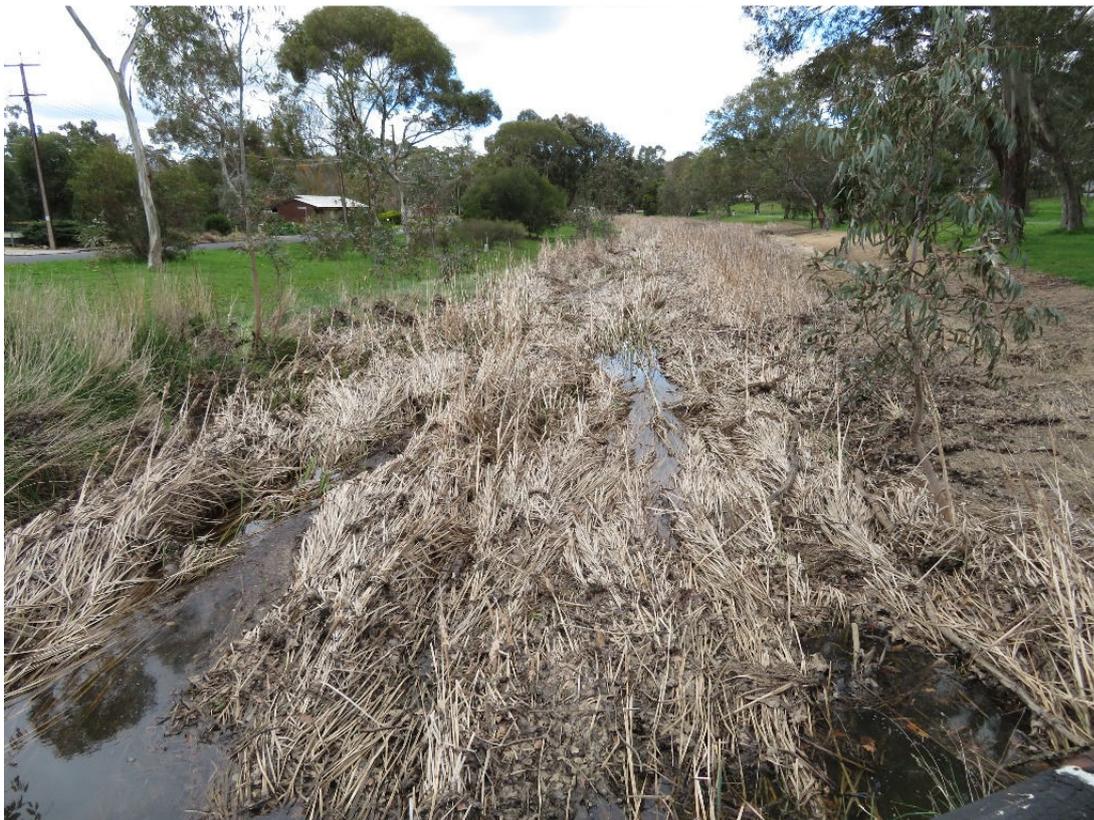
Figure 4.1 View from Bollen Road Bridge looking downstream 2019; revegetation of the northern (left) bank has occurred since 2012 and young River Red Gum saplings have also grown since then.

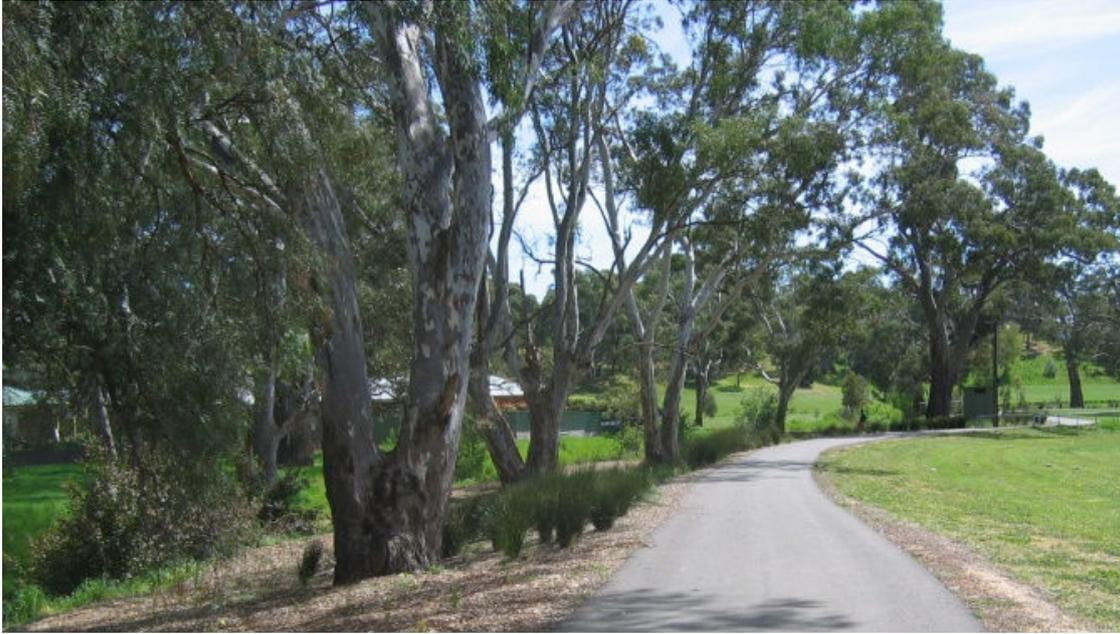
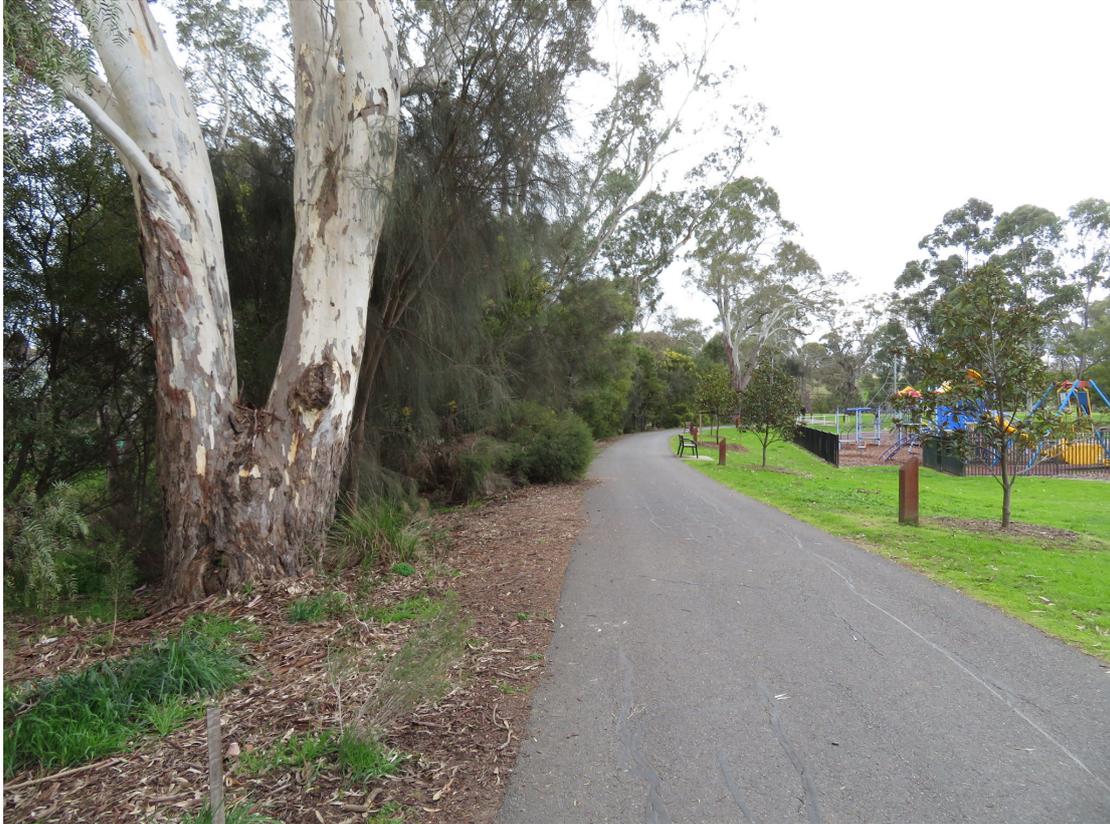
Figure 4.2 Revegetation along the watercourse in Keith Stephenson Park in 2006 (top) and 2019 (bottom) – note the successful establishment of shrubs while planted rushes have not survived

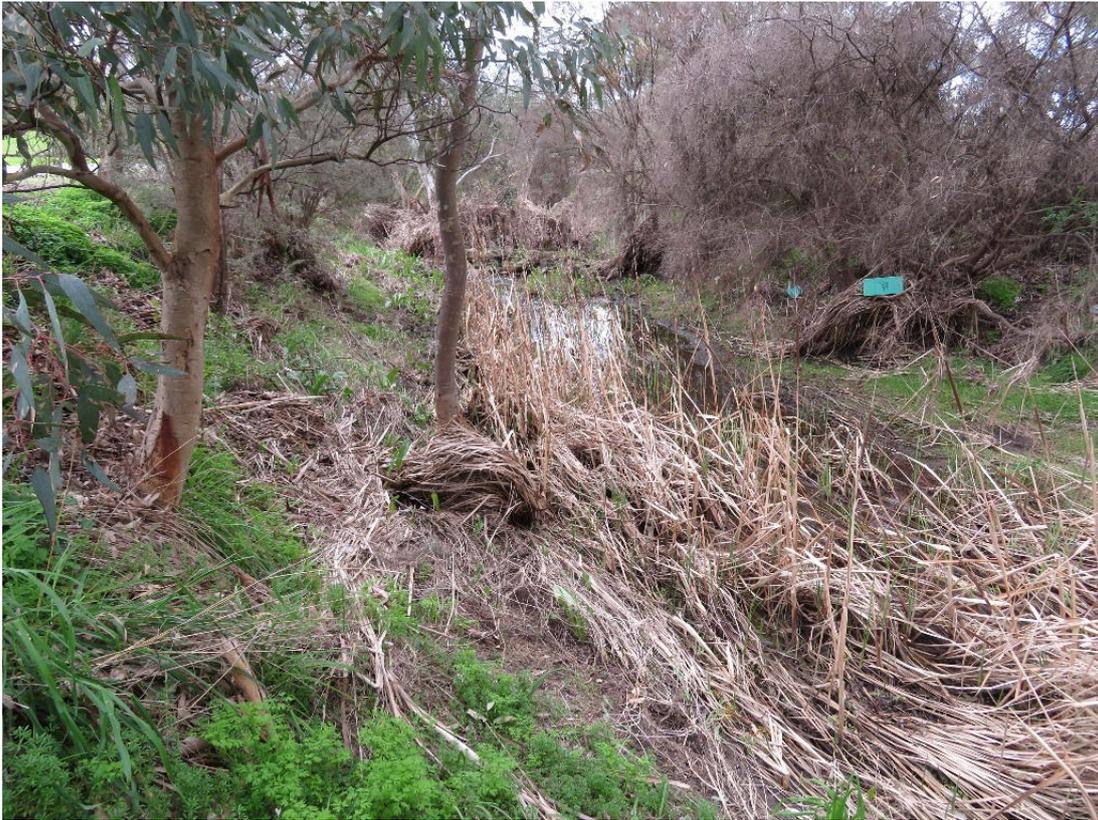
Figure 4.3 Planted and secondary regeneration of Woolly Tea Trees in the creek (2019)

The banks of the creek have been battered upstream of May Road for erosion and flood control and additional rock installed in some lower areas for further erosion mitigation. The prolific growth of bulrushes (Figure 4.1), particularly between Bolllen and Kay Roads is a concern for the Council due to the reduced capacity of the watercourse during flood events. The bulrushes are likely to have trapped silt from erosion upstream, further reducing the channel capacity. Bulrush management is discussed in Chapter 5.1. Shading by River Red Gums and Woolly Tea Trees appears to provide a natural control of Bulrushes (Figure 4.3).

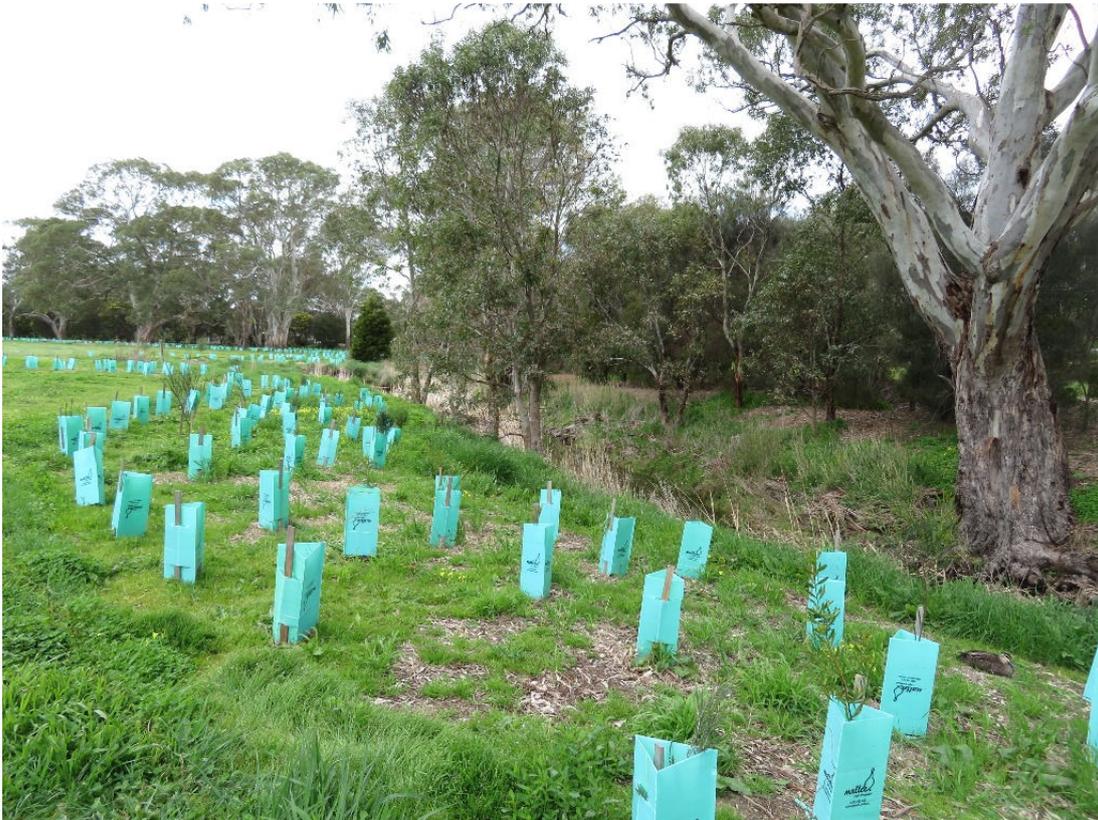
Figure 4.4 New revegetation area on the near bank and older revegetation on the far side with naturally regenerated River Red Gums in the creek (2019).

River Red Gums are scattered along the creek and throughout the surrounding parklands and the watercourse contains native Bulrush and Common Reed as well as a small number of native herbs. Revegetation of the banks and part of the park has been undertaken progressively over a number of years (Figure 4.2, Figure 4.4).

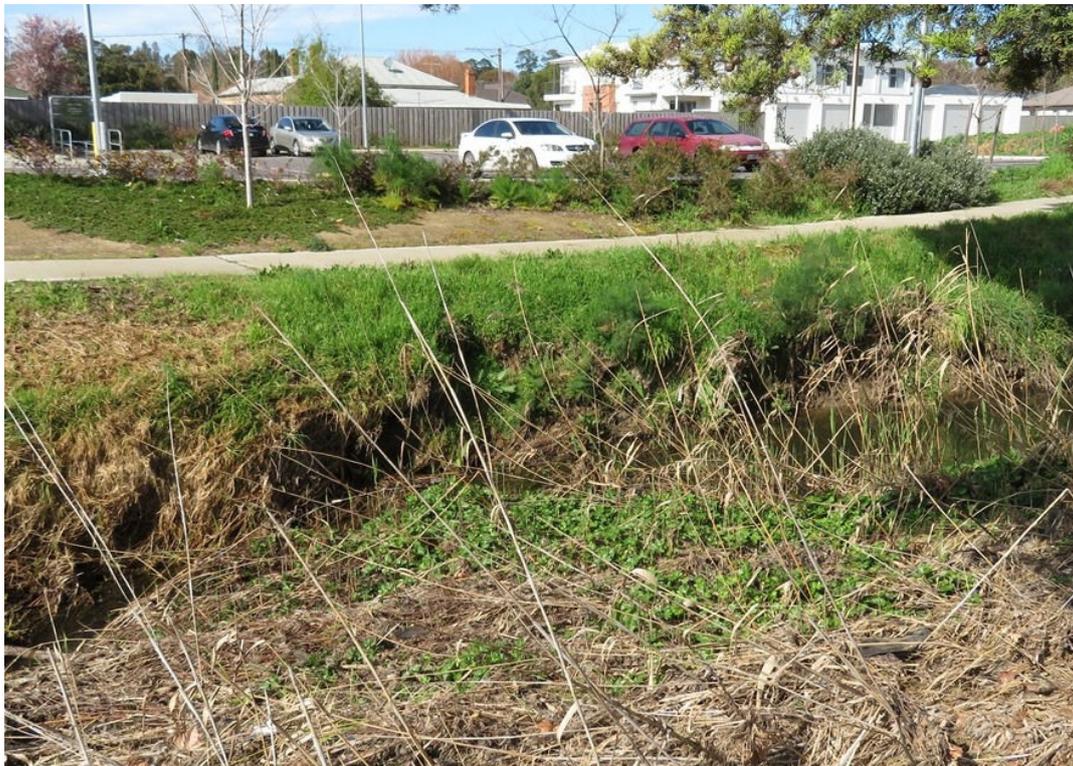
The upper and lower ends have had the banks battered and revegetated. A pony has been grazing various grassed sections for several years now; it has been tethered and moved regularly and has therefore not caused any damage to the banks or creek. An area of bank has eroded above the Hutchinson Road Bridge which has not previously been (Figure 4.5).

Figure 4.5 Bank erosion upstream of Hutchinson Road Bridge (2019)

Priority	Management Action
High	Remove high threat weeds: control Ash trees, Broom; contain Periwinkle to exotic dominated area. This will be on-going every 2-3 years
Moderate	<p>Erosion monitoring: monitor bank erosion risk to path and manage as required.</p> <p>Weed control: remove Periwinkle entirely.</p> <p>Landscaping: plant fast growing “attractive” local native species such as Blackwoods and Silver Banksia along the linear trail.</p>
Low	<p>Weed control: Remove remaining exotic trees on both the north and south banks, and woody weeds. Ensure Periwinkle and Ivy are controlled before revegetation begins. Follow-up and control re-growth of weeds. Remove non-local natives in revegetation (Sugar Gums and Silver/Black Wattle). Liaise with landholders planting in reserve to ensure no new weeds are introduced.</p> <p>Revegetation and exotic tree removal: In the longer term the exotic trees should be removed as they pose a weed threat and impact the watercourse condition. Fast growing, shady and attractive native species such as Blackwoods should be established in the short term on the northern side of the linear trail in anticipation of longer-term removal of exotic species. Revegetate banks following methods outlined Chapter 5.3.</p>

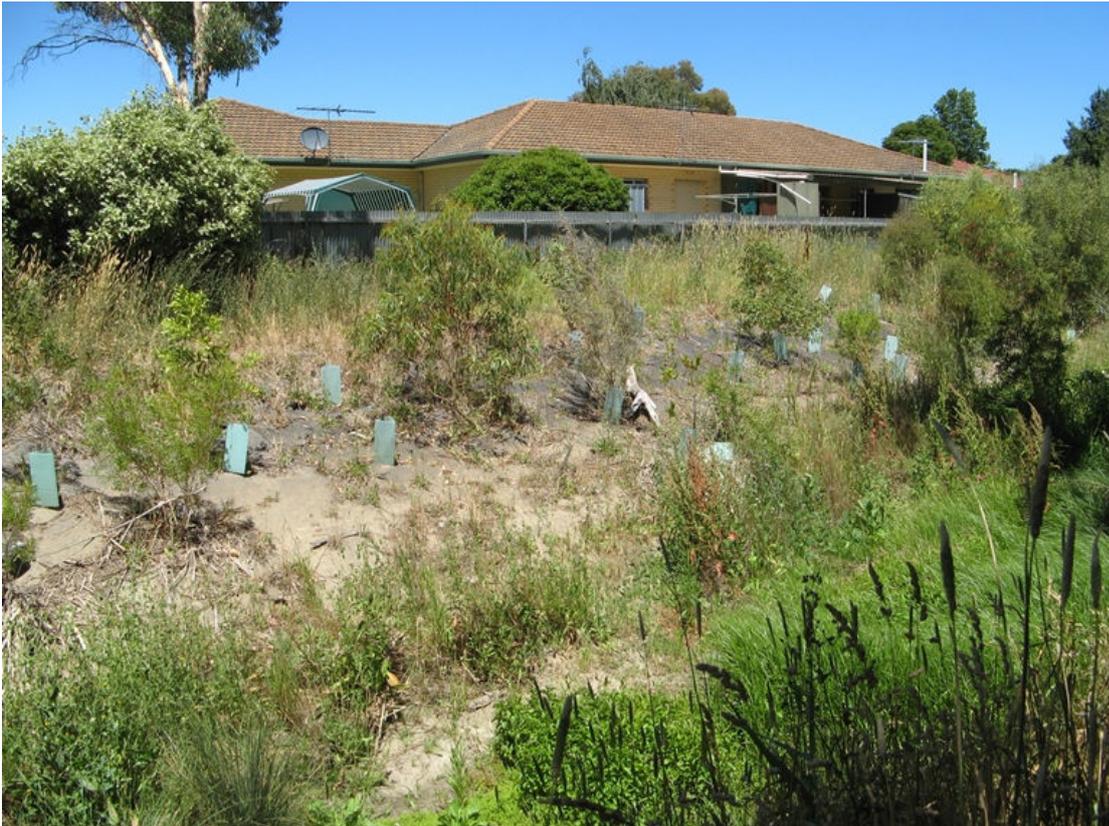
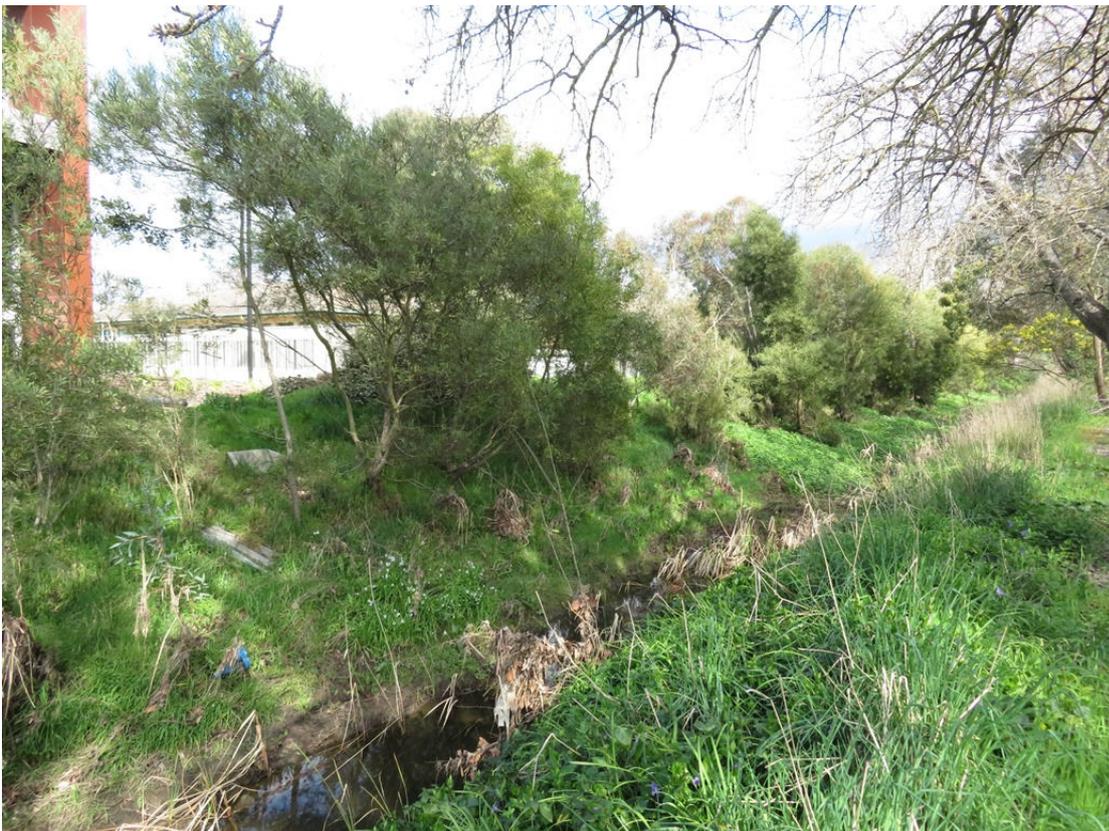
Figure 4.6 Downstream section where the southern bank was battered and revegetated; top photo taken in 2012 and bottom in 2019.

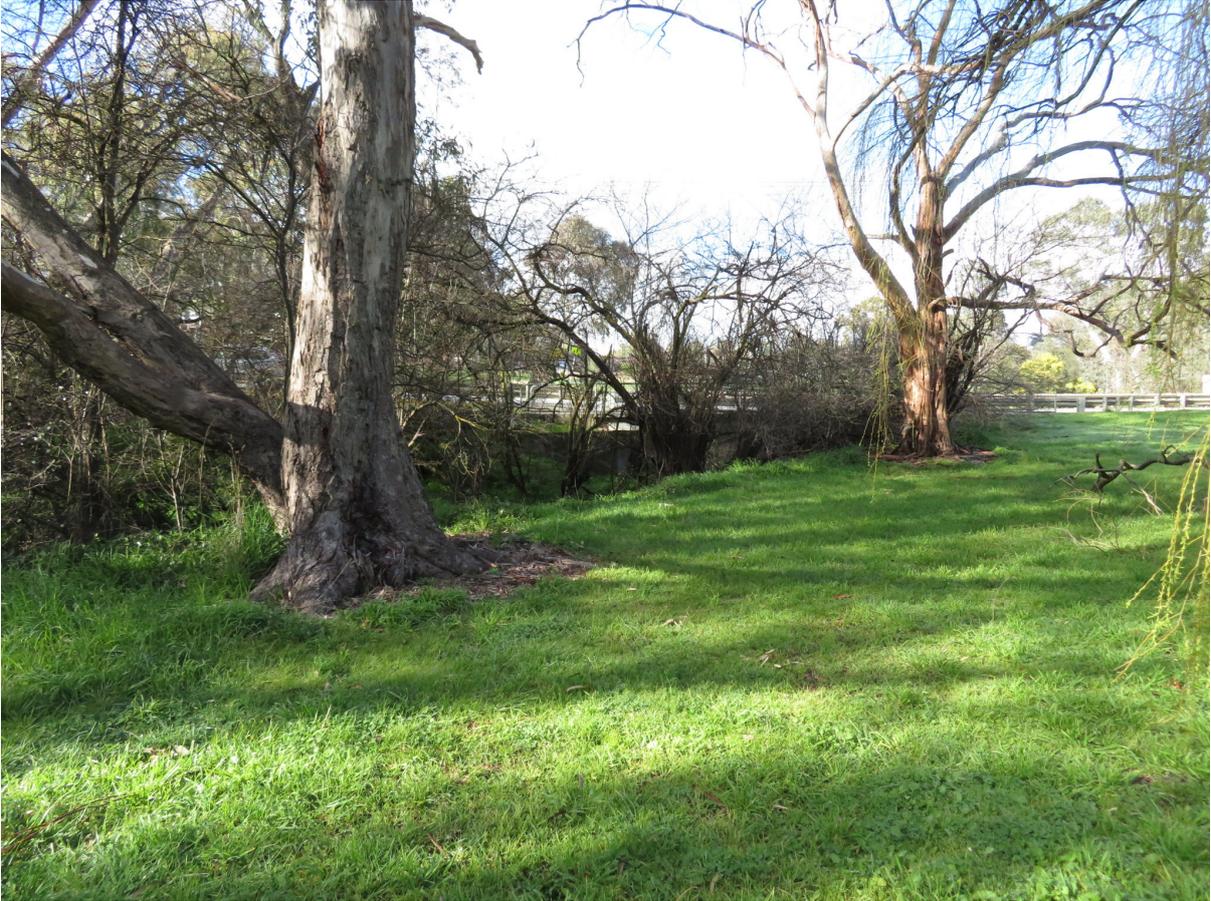
Figure 4.7 Willow Flat section (2019) – the second gum tree on the right bank has died since the 2012 survey

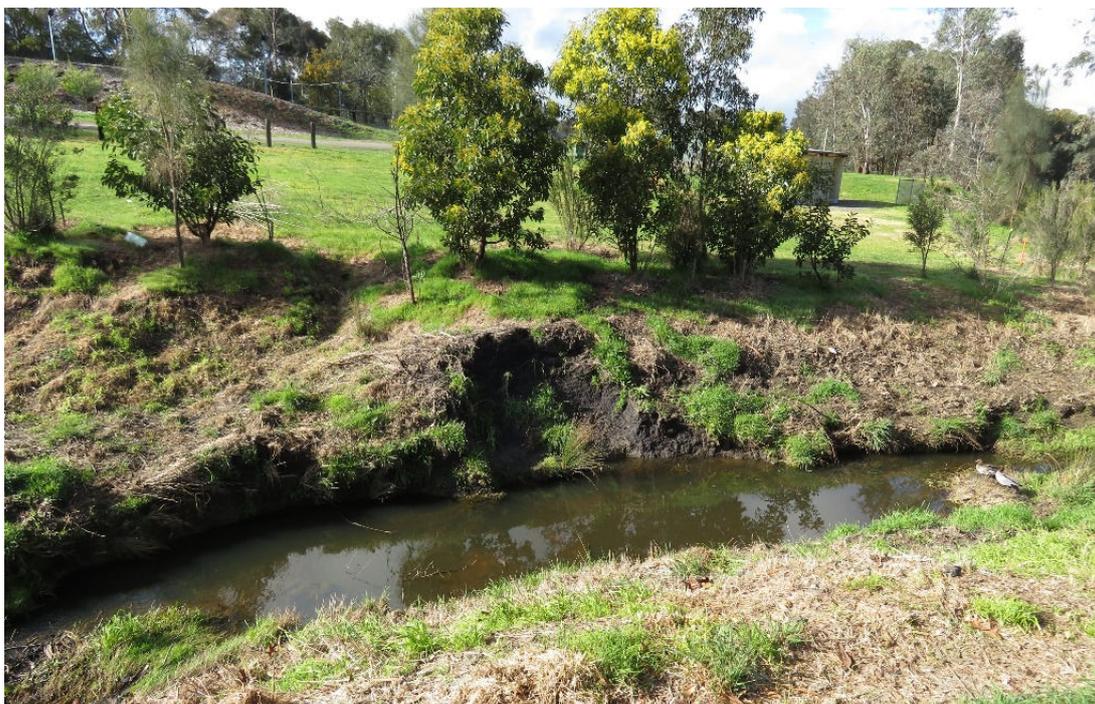
There is a significant amount of erosion throughout the entire section which was not observed in 2012 (e.g. Figure 4.8 and Figure 4.9). This may be as a result of increased run-off in the catchment, removal of grass cover on the banks as part of the revegetation preparation, site stormwater or a combination of factors. A stormwater drain from the new sports facilities outlets near the top of the bank at an outer bend in the creek and there is a significant amount of erosion at this point.

Figure 4.8 Example of erosion near upstream end of Anembo Park (2019)

Priority	Management Action
Very High	Remove high threat weeds: Gorse and Blackberry using minimal disturbance techniques (spot spray and “cut and swab”); some Blackberry is growing amongst reeds in the creek and will require a high level of care to prevent off-target damage. Monitor and control at least every two years.
High	<p>Remove exotic trees: Willows using minimal disturbance techniques (“drill and fill” or “cut and swab”) as the Willows is growing amongst reeds in the creek and will require a high level of care to prevent off-target damage.</p> <p>Remove newly established weed: remove patch of Periwinkle</p> <p>Assess erosion risk at stormwater outlet: undertake an assessment of the stormwater outlet and take appropriate action.</p>
Medium	<p>Erosion management: monitor erosion in creek and undertake appropriate action as required. When undertaking weed control works, minimise the amount of bank where groundcover is removed.</p> <p>Revegetation: maintain newly established revegetation areas through weed control and infill planting as required.</p>

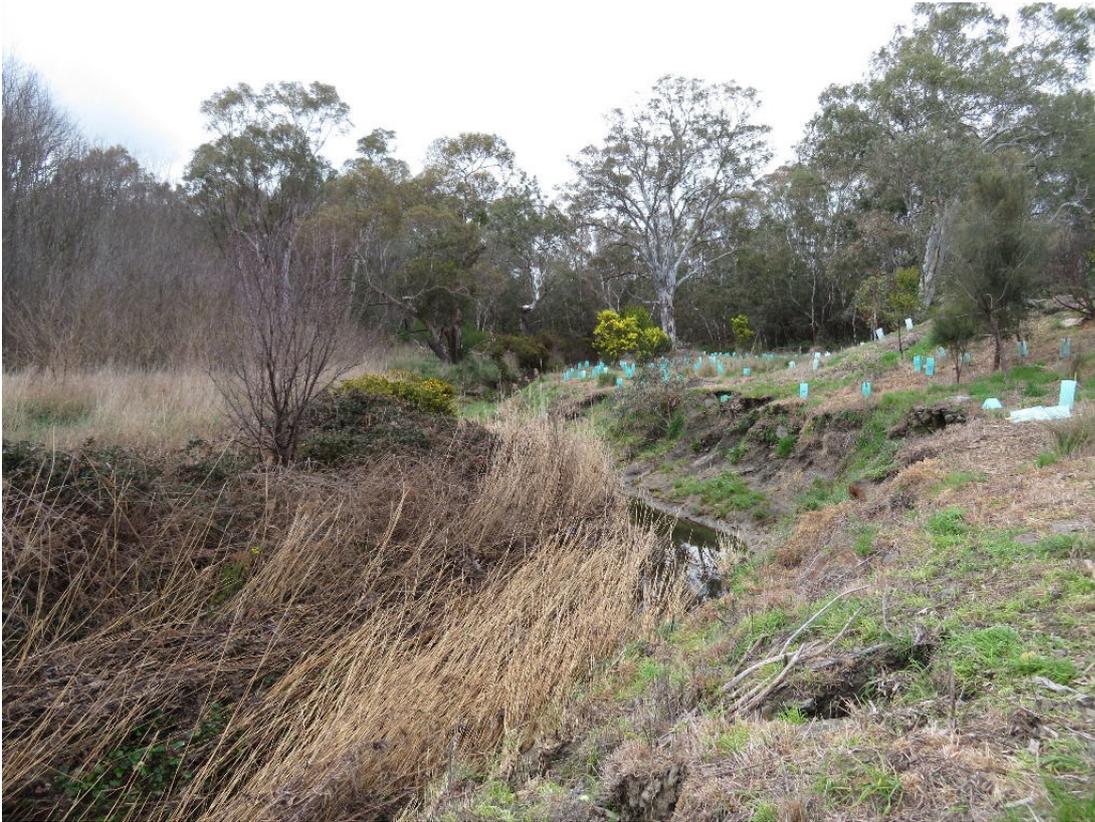
Figure 4.9 View towards Freeway (2019); Erosion at point where stormwater inlets (on right bank), note Blackberry growing through reeds and Gorse on left, with exotic deciduous trees on eastern floodplain.

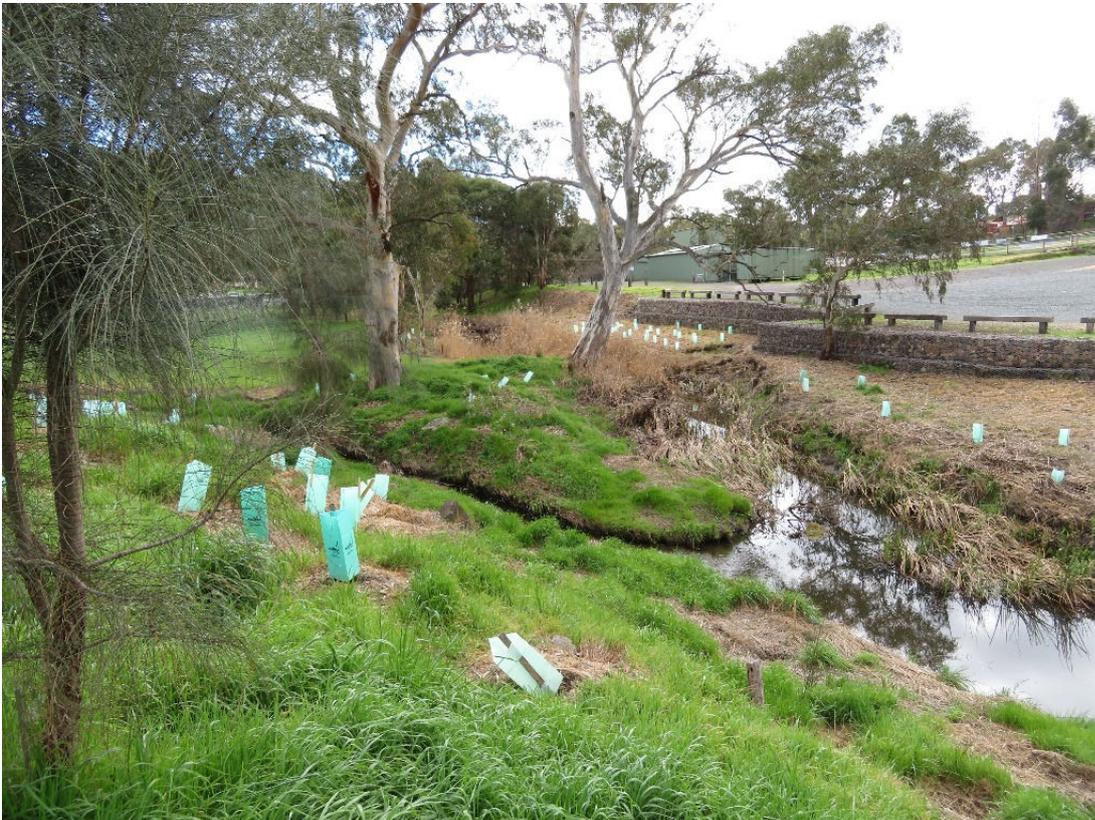
Figure 4.10 Junction of two creeks showing old and recent revegetation (2019)

A small creek enters the Littlehampton Creek from the west midway through this section (Figure 4.10); the water coming from this creek was visibly clearer than water coming from Littlehampton.

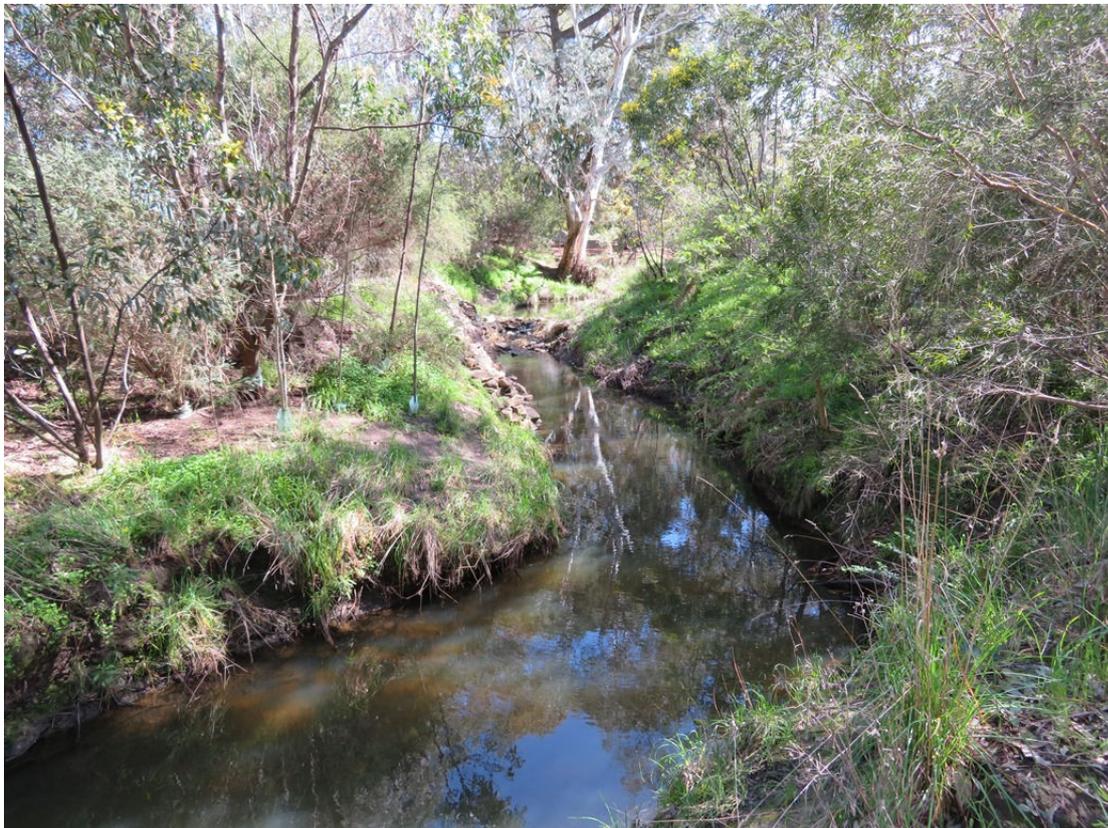
Figure 4.11 Well established revegetation shading the creek, note absence of Bulrush or Common Reed, also small amount of erosion on left bank in foreground (2019).

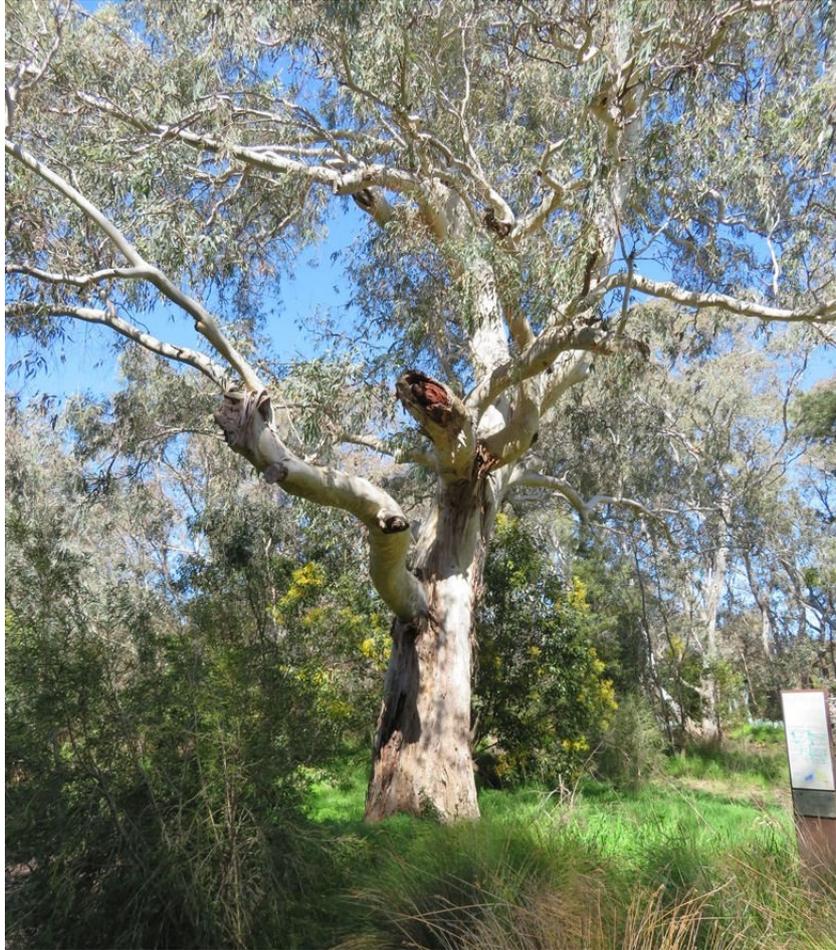
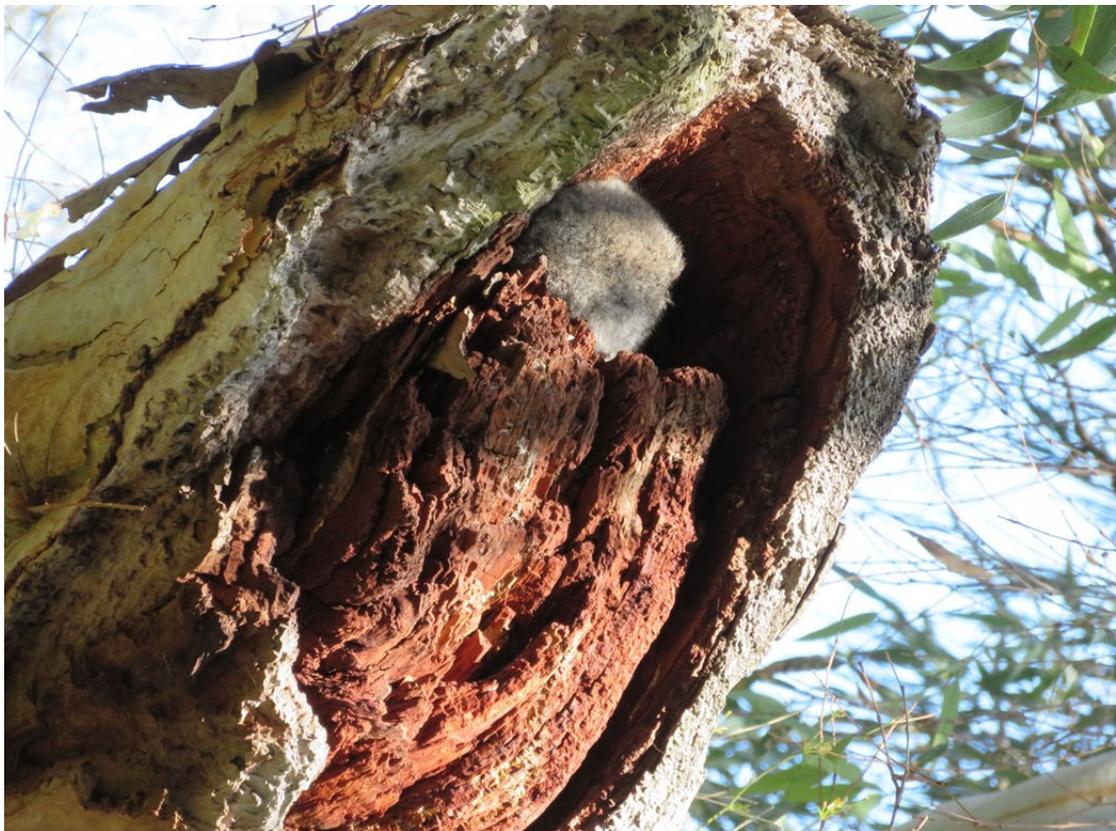
Figure 4.12 Large tree with hollows (top) and possum in one hollow (bottom) (2019)

There are many mature and regenerating River Red Gums, but limited “habitat trees” (containing hollows); some nest boxes have been installed to overcome this limitation. A possum could be seen in one of the trees with natural hollows (Figure 4.12). Stormwater wetlands have been constructed by the school and significant revegetation work undertaken in the wetlands and the riparian zones (Figure 4.11). Exotic perennial grasses dominate where the banks have not been sprayed. The revegetation areas were established and woody weeds removed between the 2006 and 2012 surveys. There has been some re-growth of woody weeds on the banks amongst the revegetation since 2012 however the overall the weed risk is reduced. Exotic trees growing in the creek downstream of the bridge have been removed and no Drain Flat-sedge was observed.

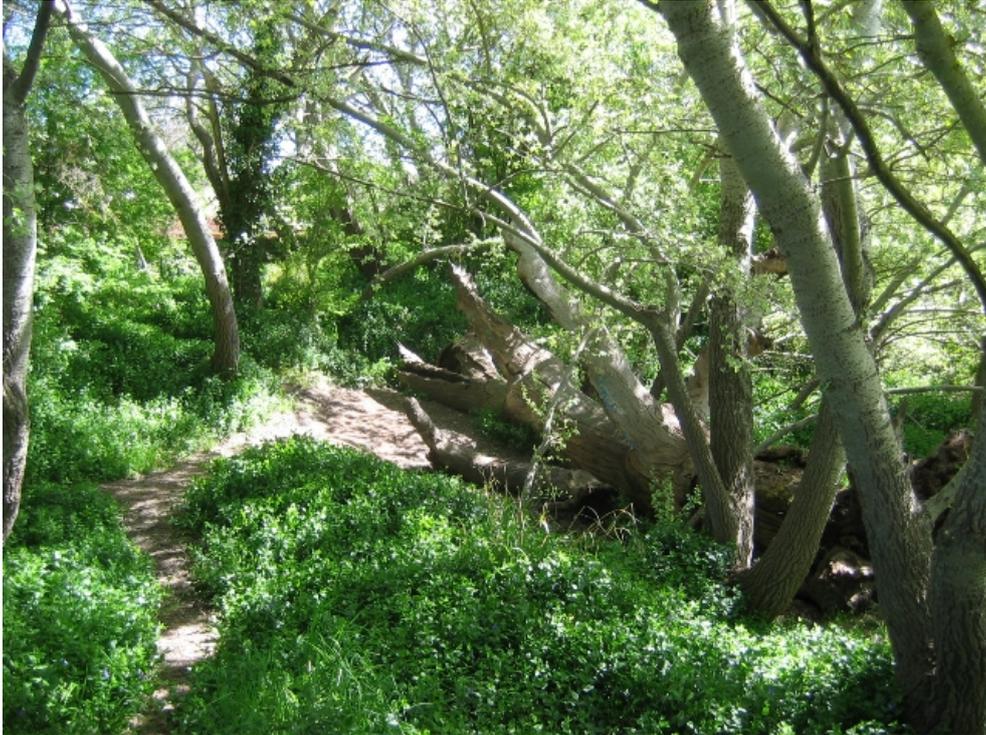
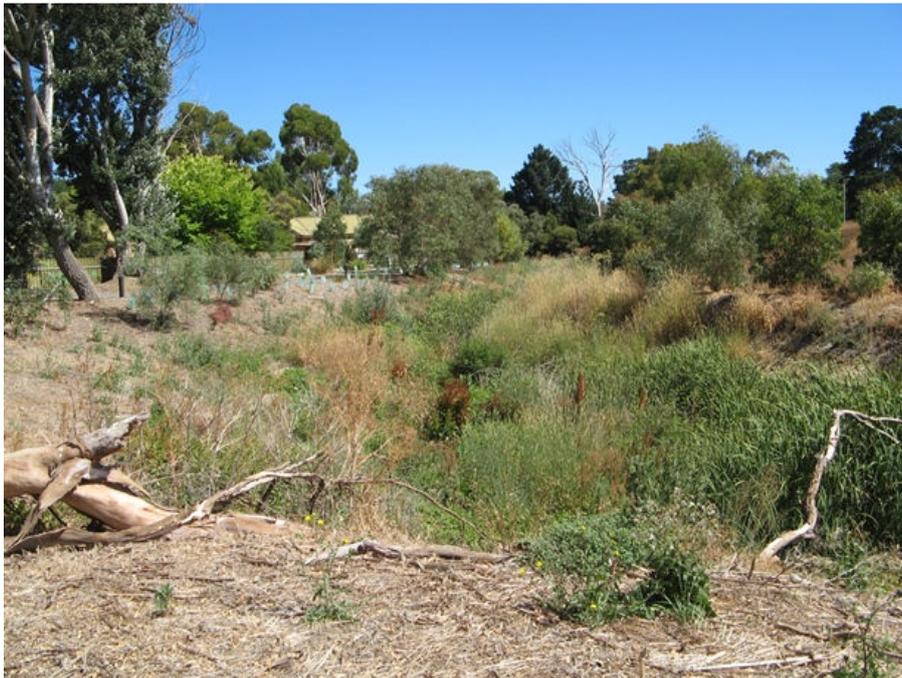
Figure 4.13 Area behind shopping centre carpark in 2006 (top), vegetation is 100% exotic species, and same location in 2012 (bottom) with exotic trees removed and native species newly planted

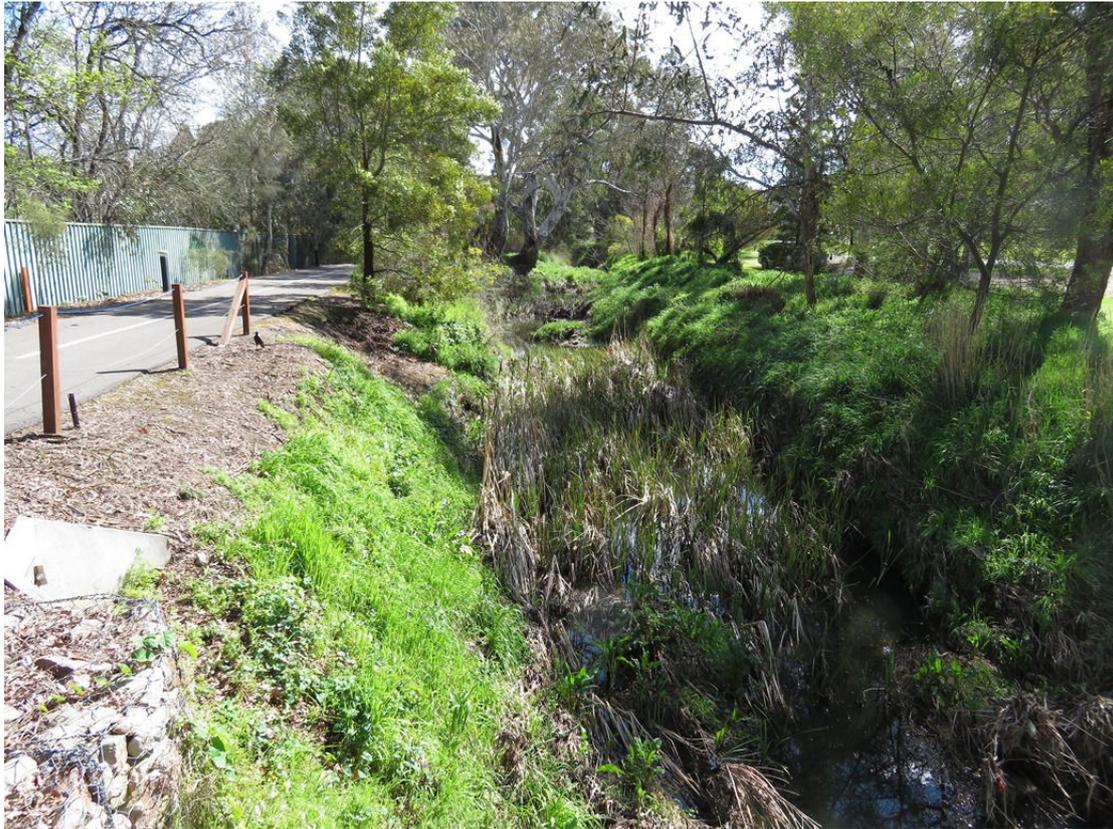
Figure 4.14 Local native revegetation in Dunn Park (2019)

Mature River Red Gums are sparsely scattered along the length of this section. Revegetation of tree and shrub species has been undertaken along much of the length where there is sufficient space, however in some areas exotic trees and groundcovers are still dominant. The section through Dunn Park is in the best condition (Figure 4.14), but climbing exotic species are a problem as they are growing up planted trees.

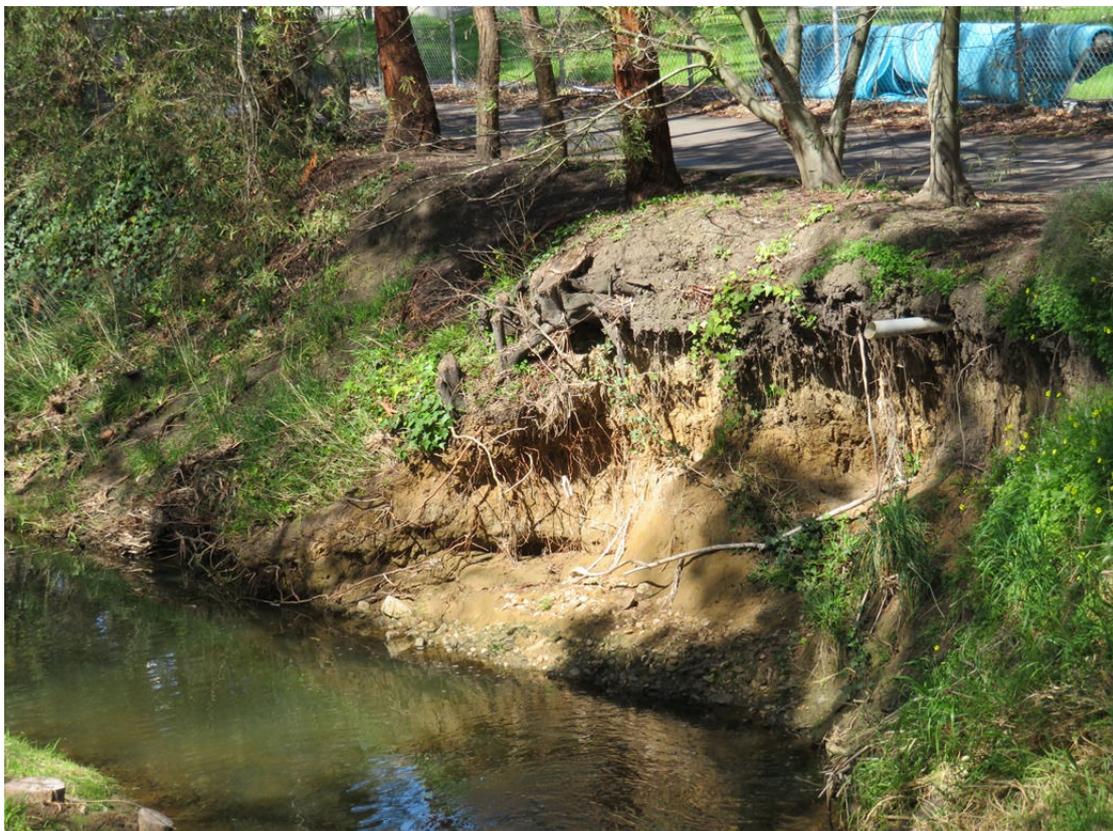
Figure 4.15 Erosion of the western bank near the swimming pool is close to trail and should be monitored (2019)

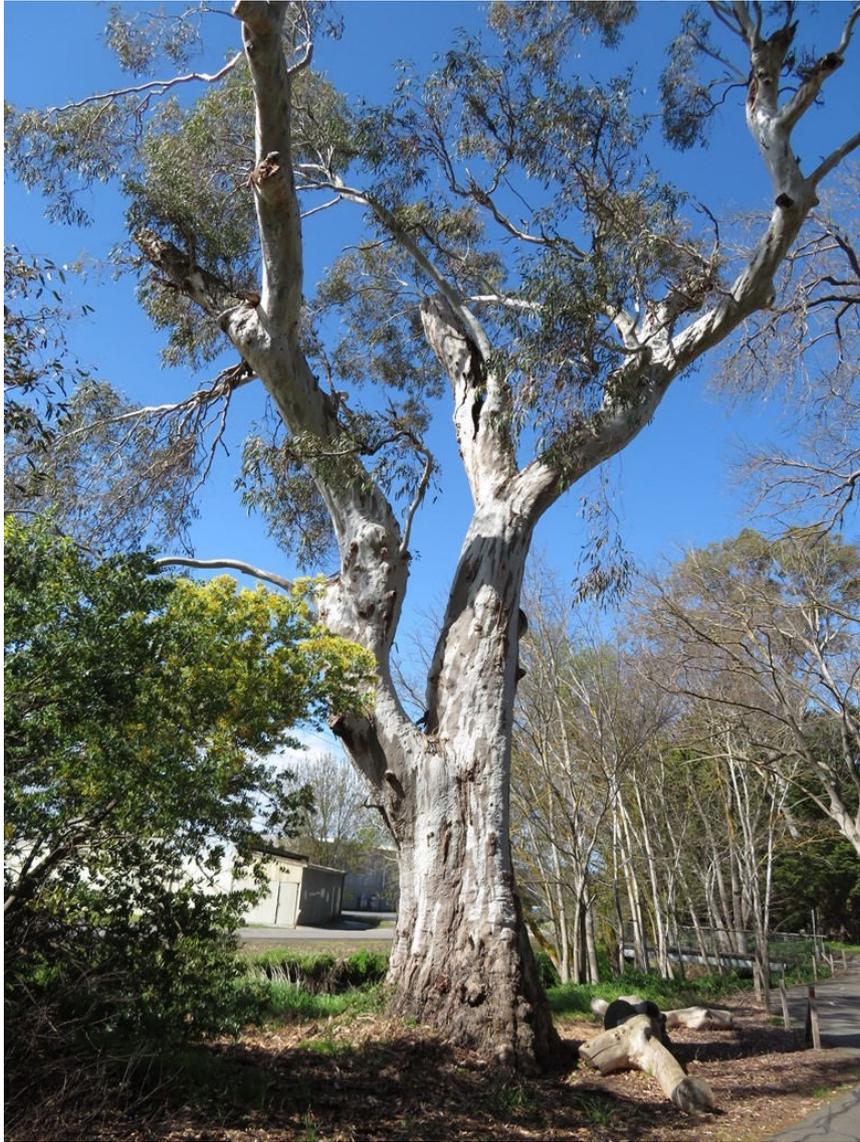
Figure 4.16 One of the few large remnant River Red gums in this section, it has a commemorative plaque (2019).

One very large River Red Gum has a historical plaque (Figure 4.16); this tree is very large and could be better promoted to incorporate it's biodiversity values and both pre- and post-European heritage.

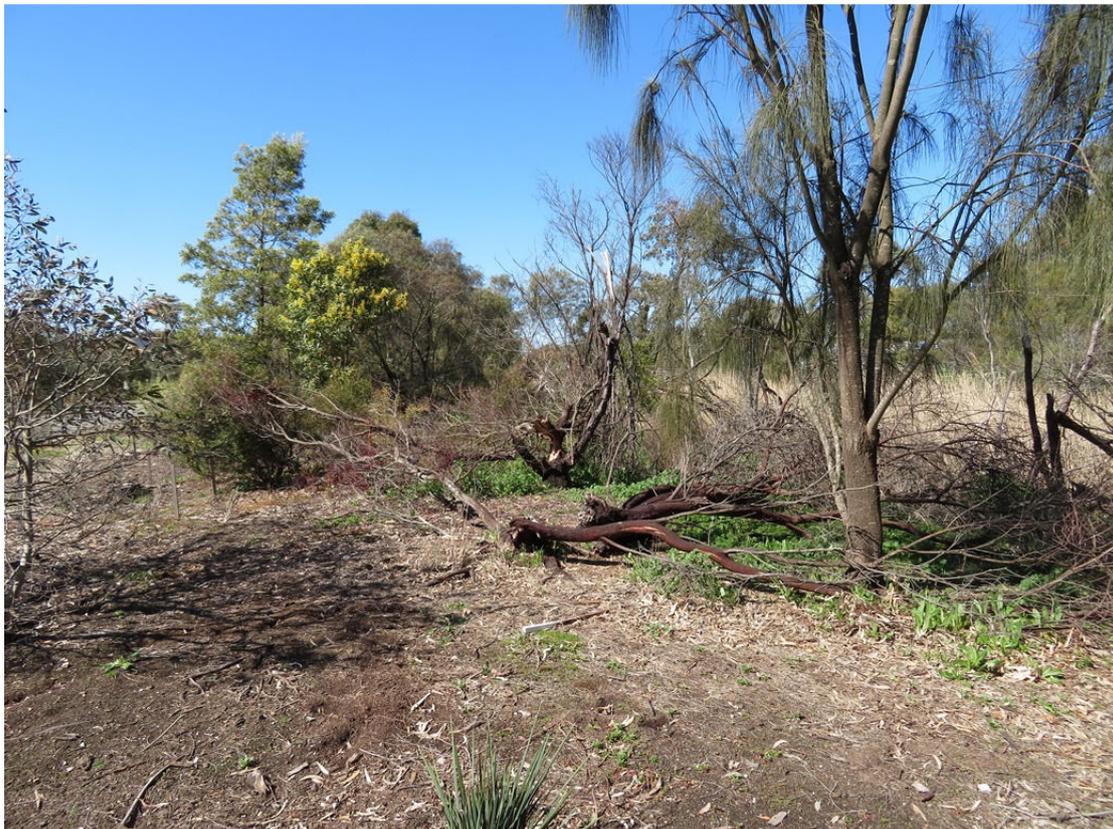
Almost all of both banks have been revegetated since 2005. There are a small number of remnant River Red Gums on the banks as well as naturally regenerating River red Gums. Many of the older revegetated Swamp Wattles have died-off (Figure 4.17), and more are likely to die over the next few years as it is a short-lived species. Further to this, many of the native grasses and sedges that were planted have died, which may be through a combination of mis-identification during weed control activities and ‘natural causes’. The only regeneration is of River Red Gums and Native Sarsparilla. There are now significant gaps in the revegetation areas and re-planting has been undertaken in some areas but more is required. The lack of natural regeneration is likely to be a combination of dense mulch being applied, use of species that require wetter conditions and misidentification during weed control. Enhancing these older revegetation areas is discussed in Chapter 5.7.

Figure 4.17 Older revegetation area where Swamp Wattles have died out (2019).

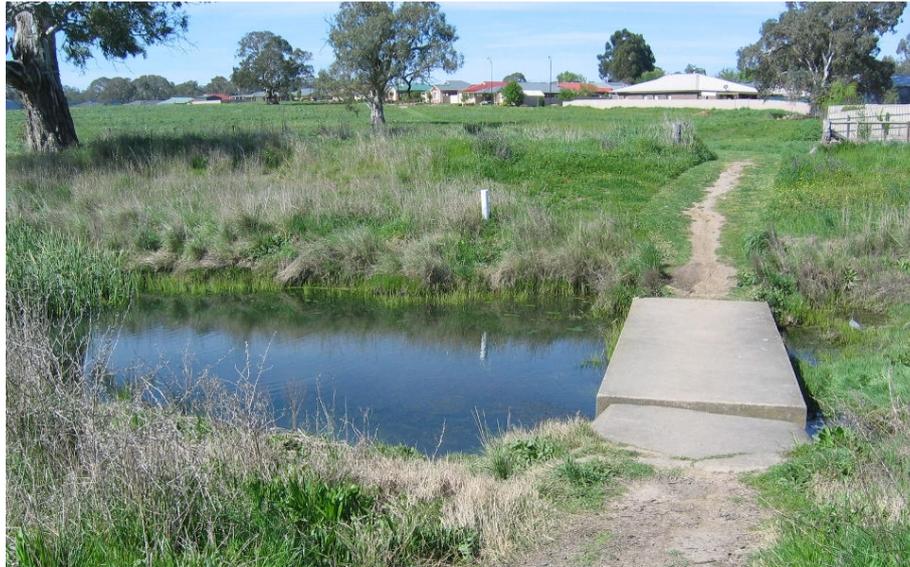
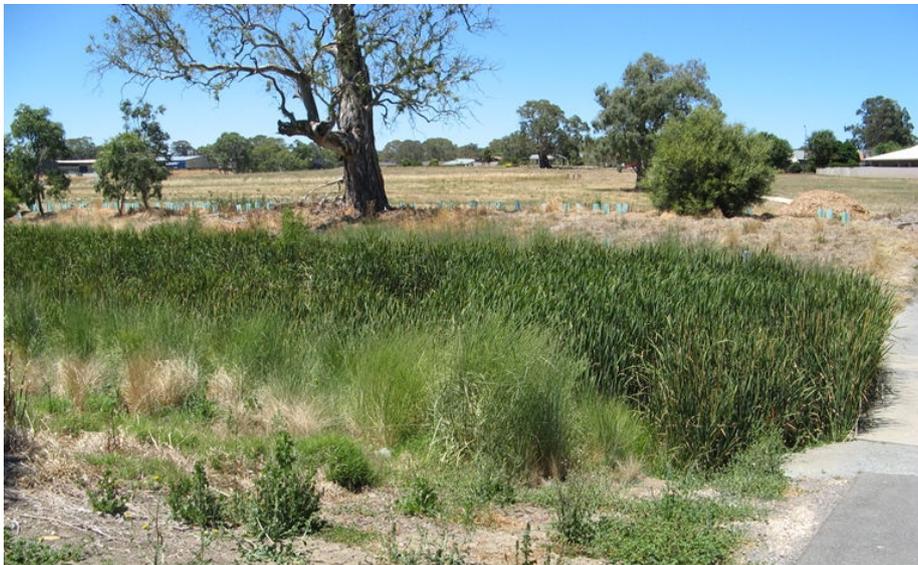
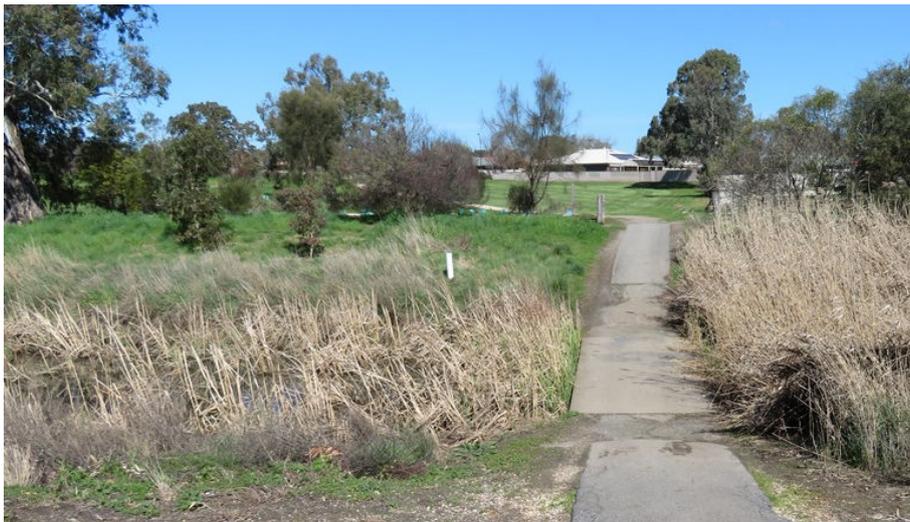
Figure 4.18 View across the ford in 2006 (top), 2012 (middle) and 2019 (bottom), following channel widening, the pool silted up and Bulrush and Common Reed became the dominant watercourse vegetation; revegetation planted in 2012 is maturing.
