Watercourse Management Plan for Mount Barker

A Report to the Mount Barker District Council

Miles Environmental Pty Ltd

2019

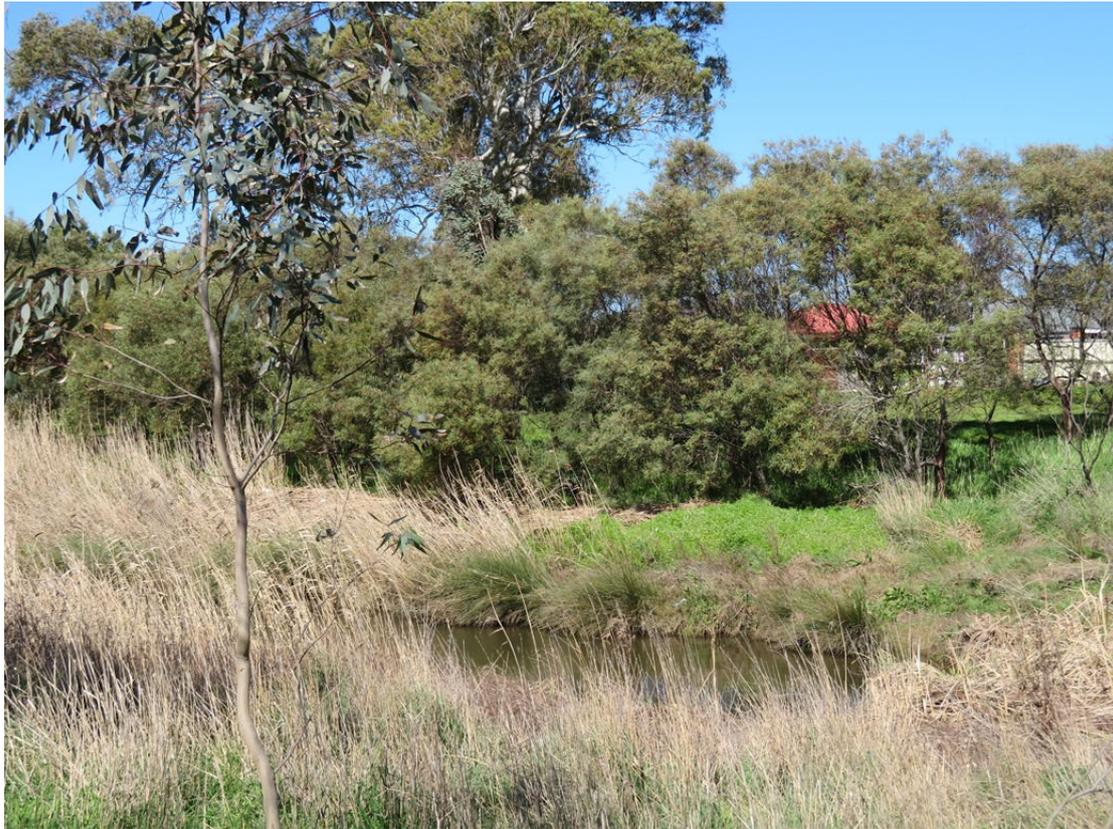
Figure 4.19 Pool in 2019 that has formed since 2012 (note Spiny Rush on far bank), River Red Gum sapling in the foreground is from natural regeneration, the wattles on the far bank are revegetation.

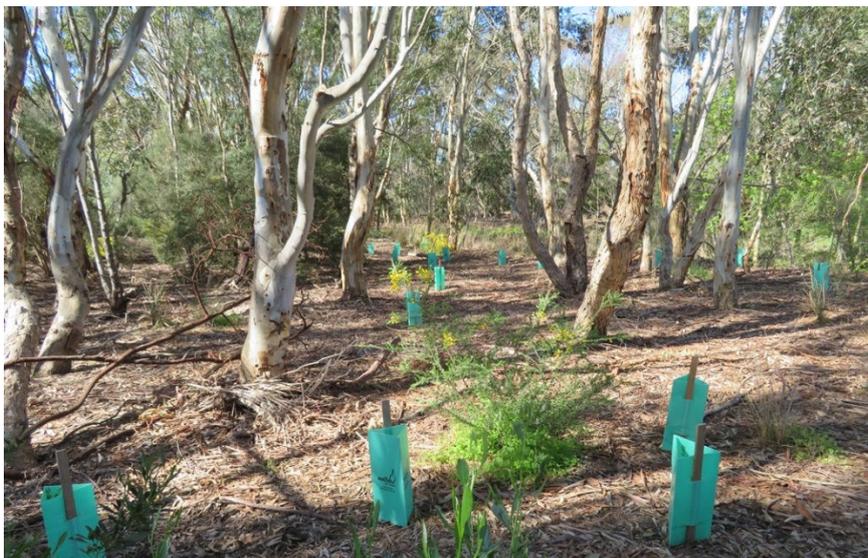
Figure 4.20 Older revegetated eucalypts with newer plantings (2019); note the naturally maintained mulch of leaf litter and minimal grassy weeds.

There are several significant changes that have occurred in this section since the 2012 survey, both positive and negative. Positive changes are that the revegetation is maturing, natural regeneration is occurring and new plantings include a greater diversity of species, particularly groundlayer species (Figure 4.20). Revegetation has also been completed along the southern bank, and new wetlands have been established both north and south of the creek, extending the area of continuous riparian and wetland habitat in this area. The diversity of species observed in the revegetation was the highest of all sections in this survey. River Red Gums and Swamp or Silver Wattle have regenerated at the base of the banks and Water Ribbon is growing in several pools. There is also significantly less Spiny Rush, Blackberry, *Watsonia* and Gorse due to the Council's control program, although there has been some re-growth of Spiny Rush that requires follow-up, particularly downstream of the ford.

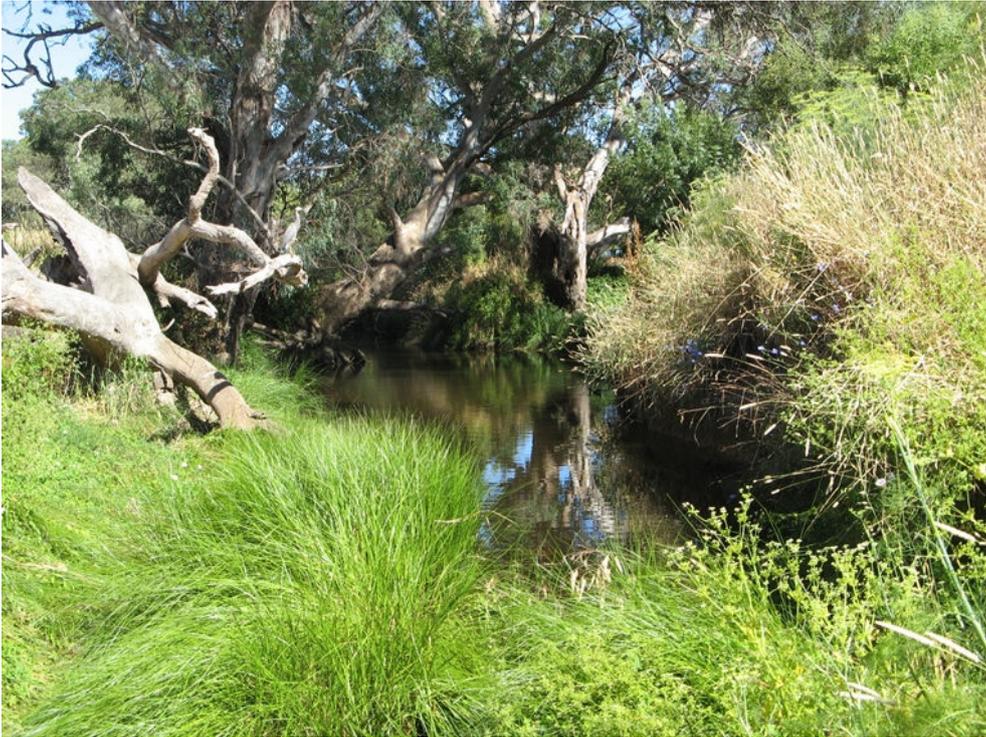
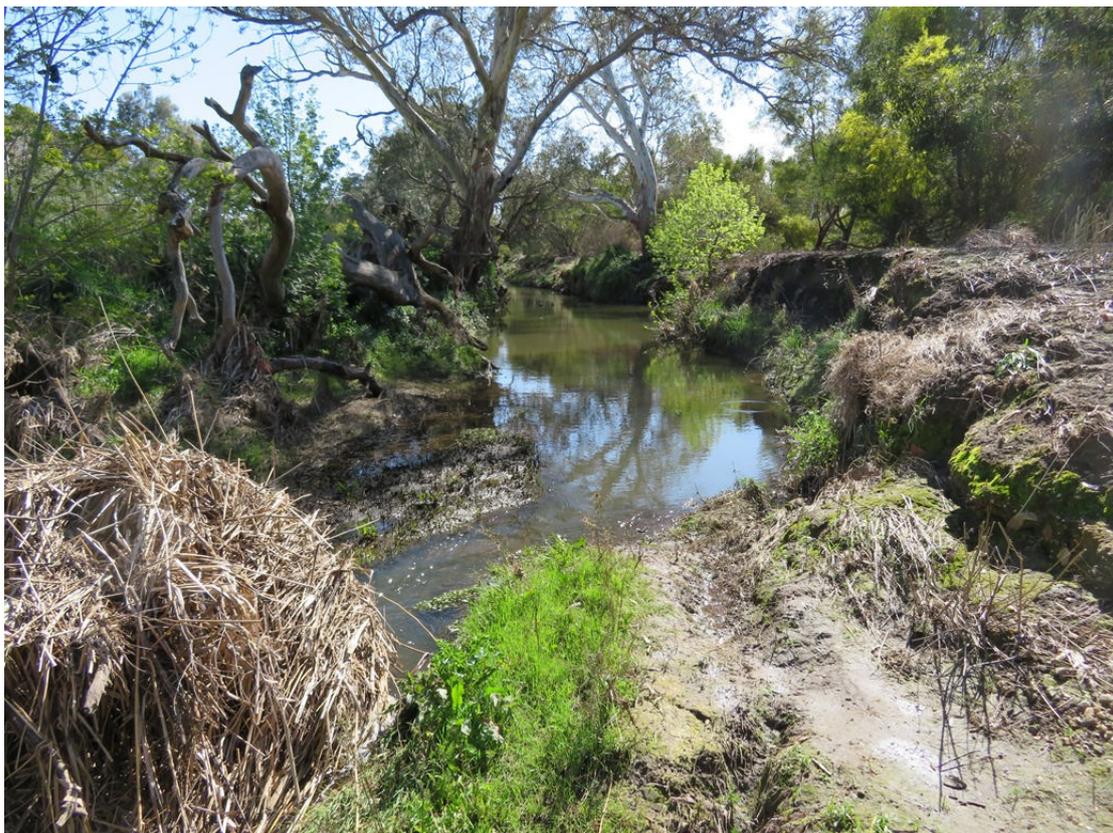
Negative changes are a significant amount of bank erosion and re-growth of Desert Ash. In the 2006 survey, a small number of erosion points were noted where minor drainages enter the creek and some bank erosion was observed upstream of the ford, one instance of which was due to a fallen tree diverting flow towards the bank. In 2012 the level of erosion was considered minor despite heavy rainfalls in the preceding Summer. In this survey (2019), bank erosion was observed throughout the section, despite there being no significant flow events in the last two years (Waterconnect 2019) (see for example Figure 4.21 and Figure 4.22). It is possible that the erosion was started during the major flood events that happened in 2016 and has not yet stabilised. In general, the erosion does not threaten any infrastructure assets and there are sufficient riparian buffers to allow for channel movement. However it is recommended that the erosion be regularly monitored following any significant flow events risks to assets assessed. Care should also be taken when controlling weeds to ensure banks are not left at risk of erosion. Planting seedlings of native shrubs such as Woolly Tea Tree and River Bottlebrush at the base of bank erosion points may assist to provide a 'soft engineering' solution at some locations. The relatively natural geomorphology and abundance of permanent pools should be maintained.

Figure 4.21 View above ford in 2012 (top) and 2019 (bottom), note erosion of banks in 2019 photo.

Priority	Management Action
Very high	Weed control: removal of Ash Trees, Blackberry and Spiny Rush. Undertake follow-up control at least every two years.
High	Weed control: Control patches of Periwinkle, working from outer edges of patches, take care not to leave banks bare; control other high threat weeds (e.g. Broom, Ivy, Blackberry) Erosion management: undertake an assessment of erosion threat to infrastructure and undertake appropriate action as required. Plant native species at the base of banks to provide soft-engineering protection for banks. Establish protective shrubs (Woolly Tea-Tree) at the base of outer bank erosion points.
Medium	Revegetation maintenance and enhancement: on-going weed control and planting understorey species as required

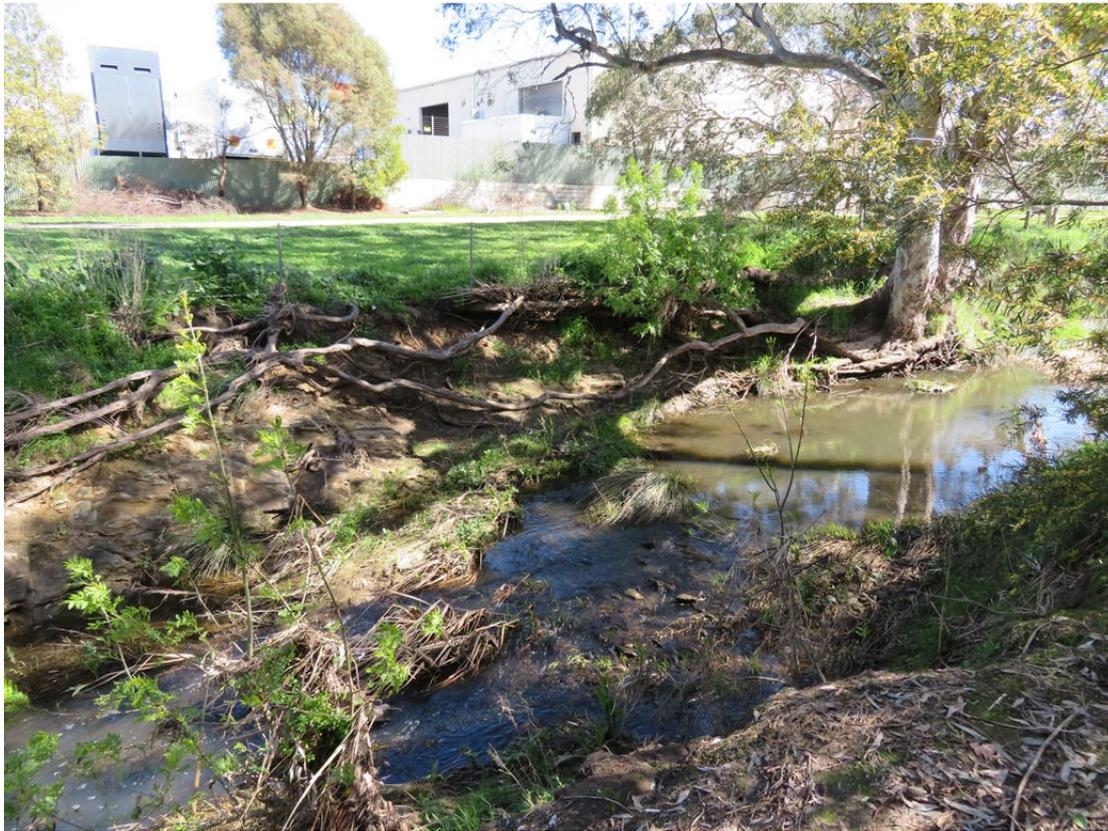
Figure 4.22 Erosion of the southern bank (2019), note exposed tree roots and fence that is now suspended over the eroded section; also note Ash saplings in foreground and on far bank.

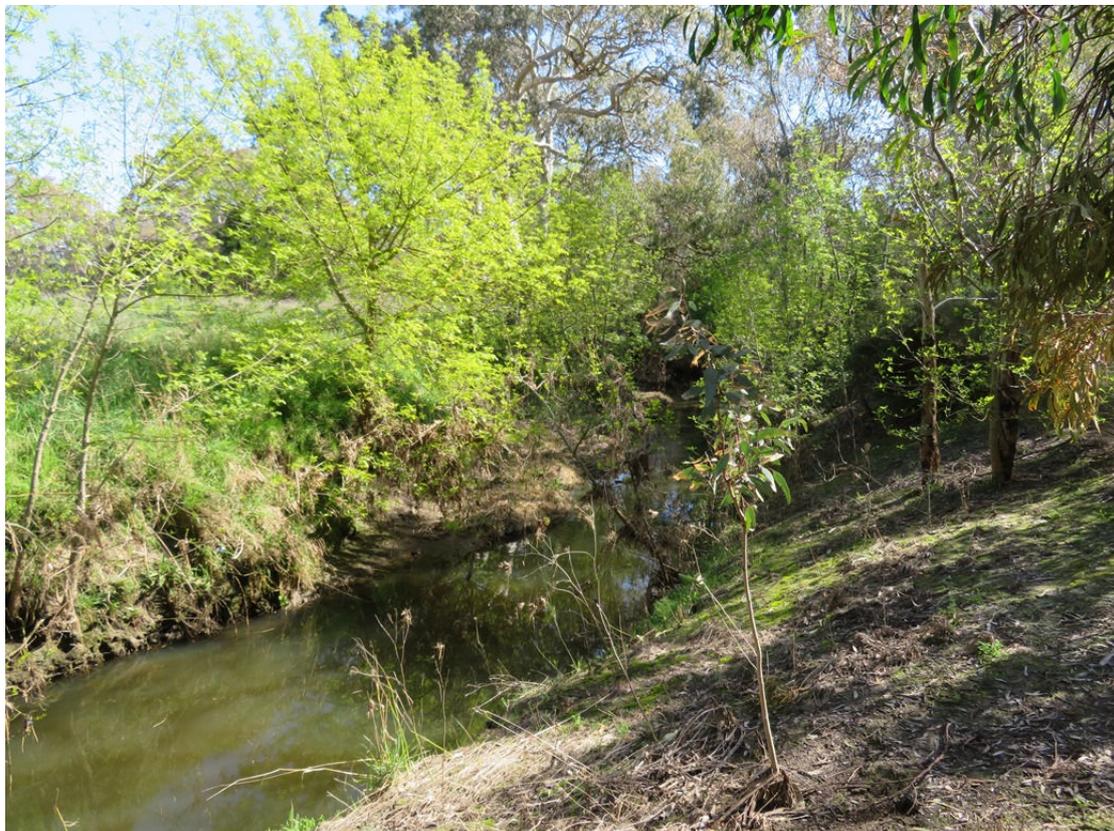
Figure 4.23 Abundant Ash trees growing along the creek (2019)

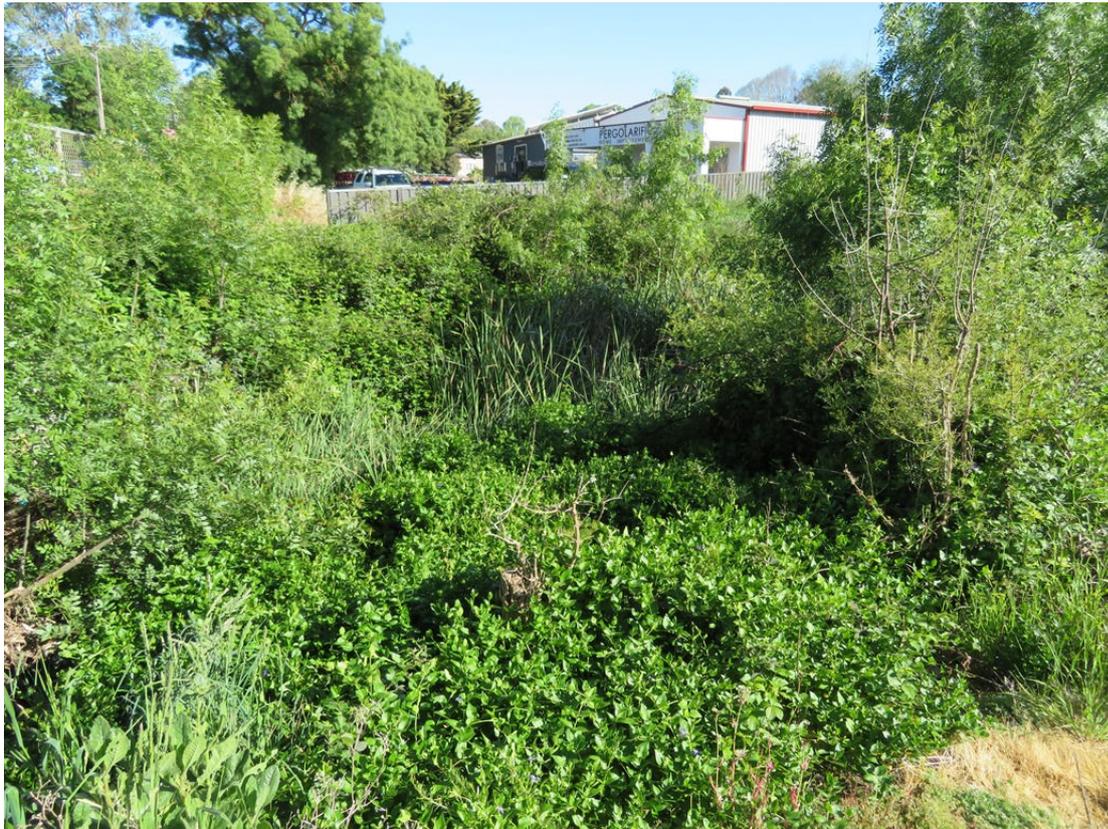
Figure 4.24 Dense weeds (Blackberry, Periwinkle and Desert Ash) immediately downstream of the Wellington Road bridge (2019).

Priority	Management Action
Very High	Weed control: removal of declared weeds Blackberry and Gorse. Undertake follow-up weed control at least every two years.
High	Weed control: removal of exotic trees (e.g. Desert Ash, Willows). Control patches of Periwinkle, working from outer edges of patches, take care not to leave banks bare. Control other high threat weeds (e.g. Broom, Arum Lily). Undertake follow-up weed control at least every two years.
Low	Revegetate open areas: revegetate banks and associated floodplain where there is sufficient space and in consultation with adjacent landholders.

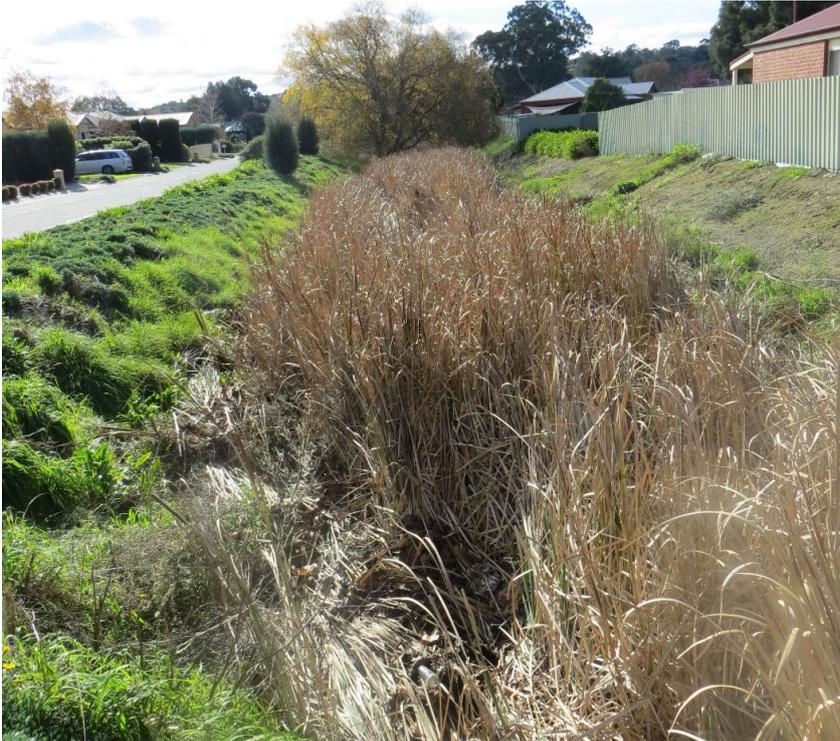
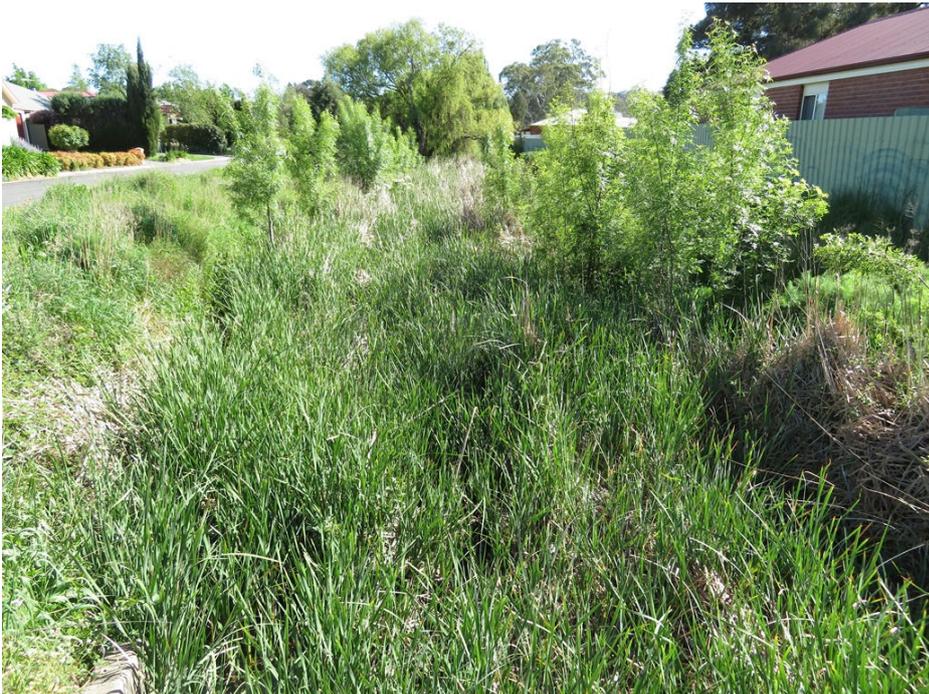
Figure 4.25 Railway Creek looking downstream from Alexandrina Road bridge in July 2013 (top) and October 2019 (bottom), note narrow riparian width and growth of Desert Ash trees in 2019.

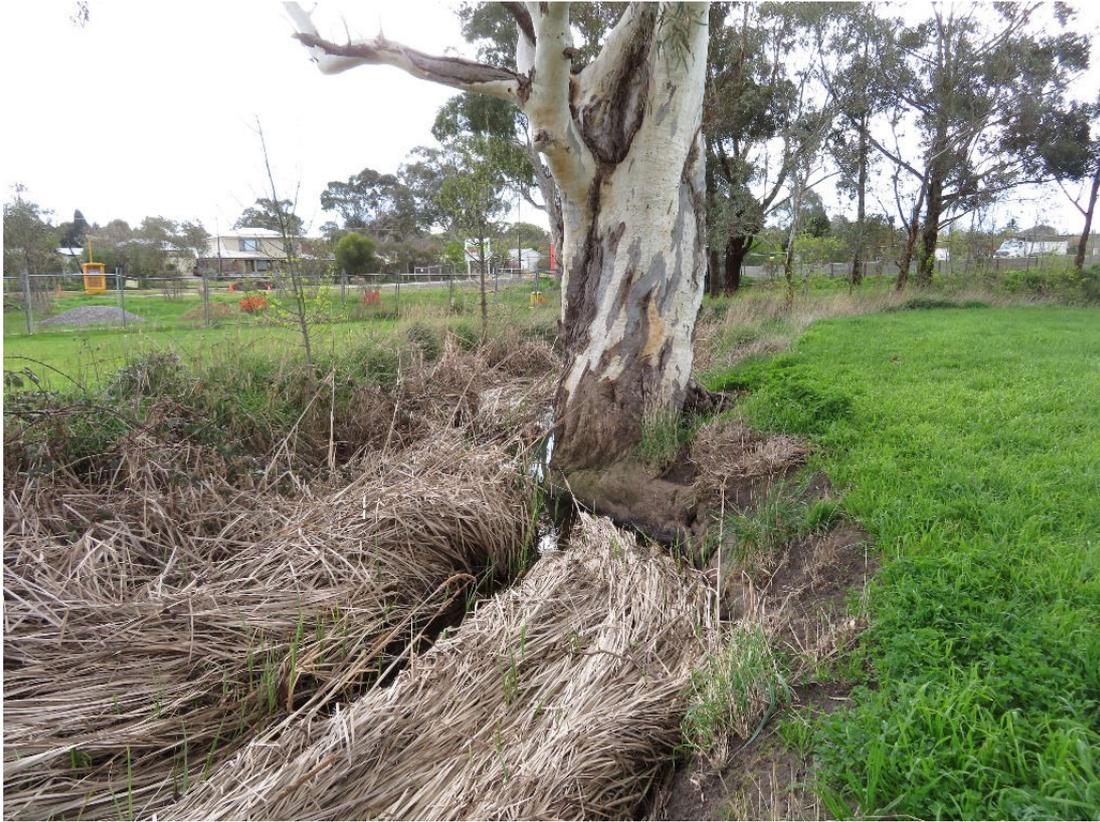
Figure 4.26 Small potentially permanent pool beneath River Red Gum (2019); note Blackberry and Ash saplings on left bank.

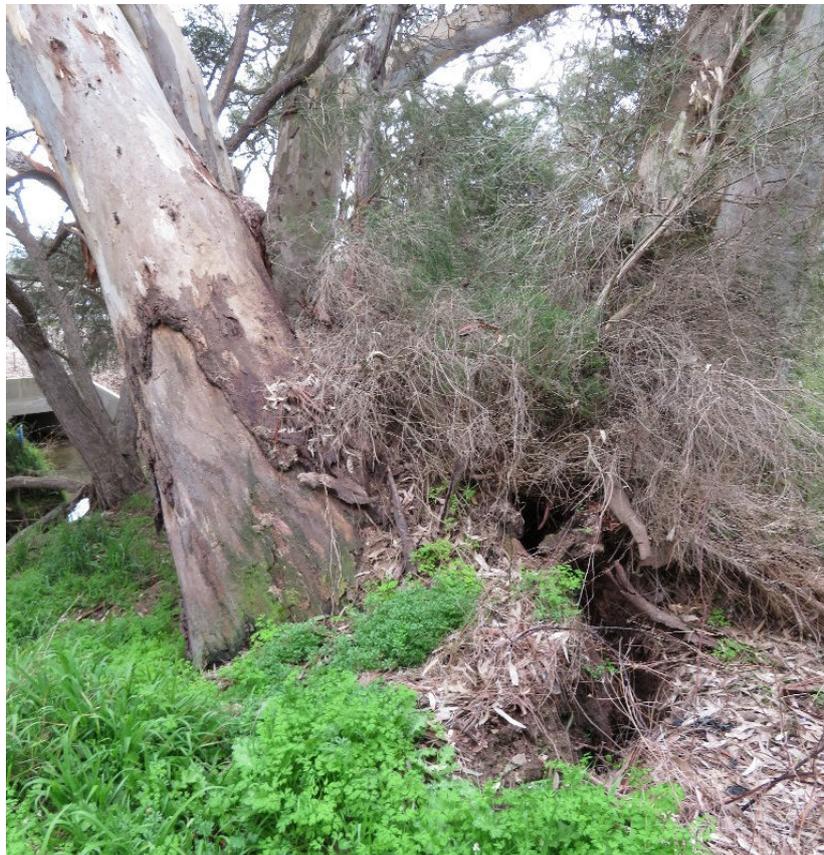
Figure 4.27 River Red Gum which appears to be falling over (2019).

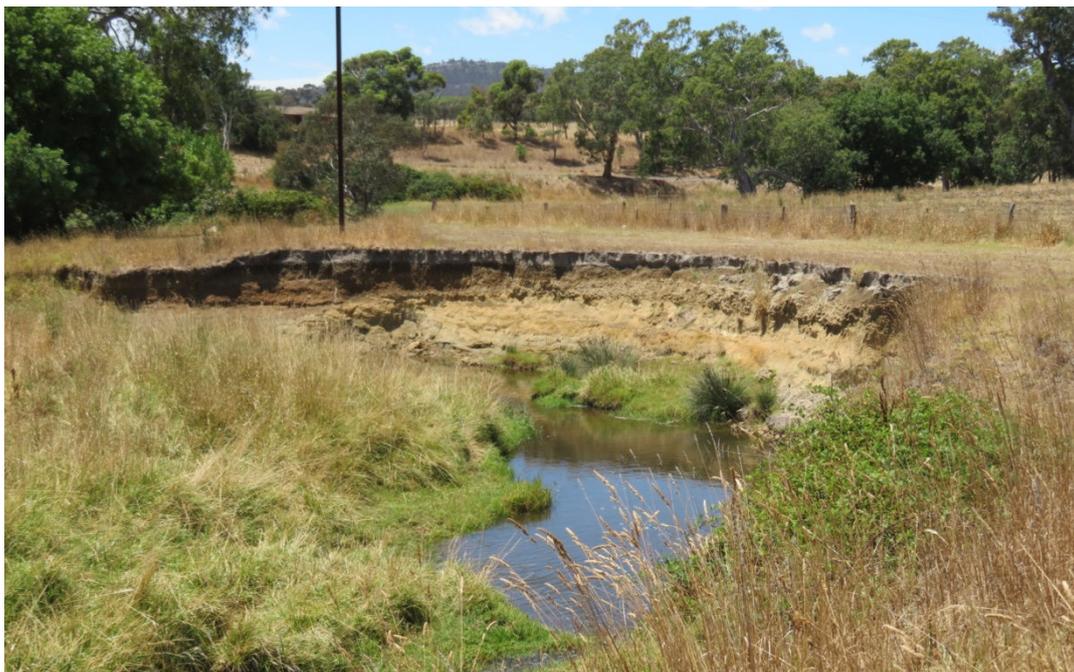
Figure 4.28 Outer bank erosion (2018).

Medium	<p>Undertake Revegetation: Undertake revegetation of the watercourse and adjacent riparian zones as per the methods and species provided in Miles (2018).</p>
Low	<p>Control Erosion: Monitor side gully erosion and control if necessary. Establish protective shrubs (e.g. Woolly Tea-Tree, River Bottlebrush) at the base of outer bank erosion points.</p>

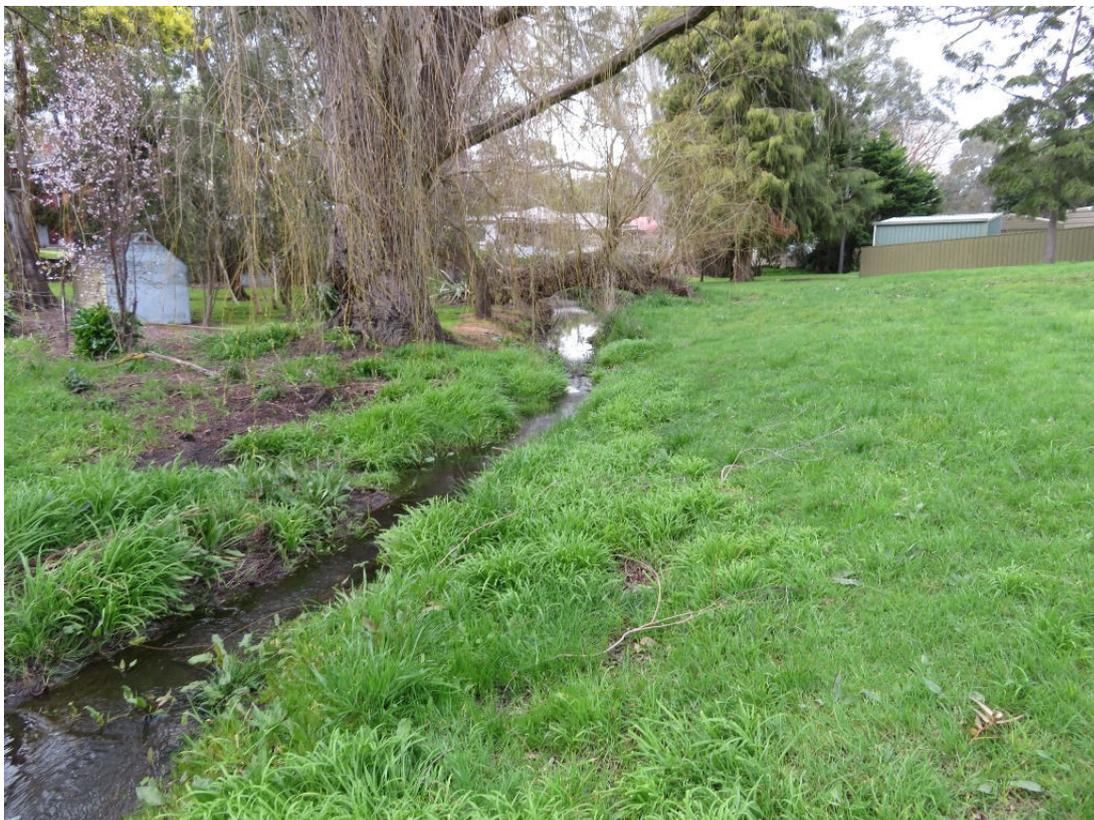
A small creek through a wide reserve off Manor Court that then narrows with houses either side. Many exotic trees planted along the creek. A small weir. Some garden encroachment. Used for passive recreation.

Figure 4.29 Tributary creek in reserve adjacent Manor Court (2019).

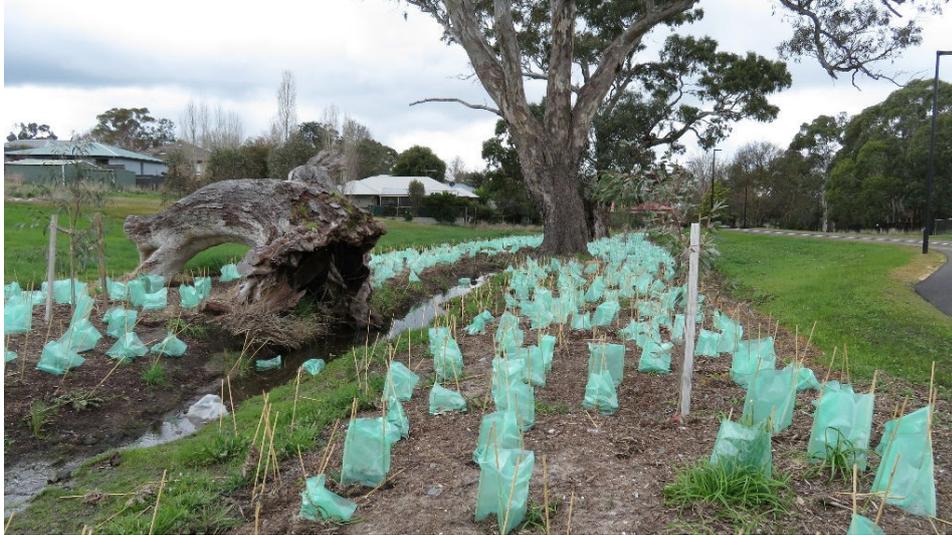
The watercourse between the new residential care facility and Mount Barker Primary provides a good example of high diversity watercourse revegetation. The use of plastic tree guards will require regular checks to ensure they are not washed or blown away. The drainage line has been shallow excavated and there is minor in-stream erosion.

Figure 4.30 Revegetation of watercourse behind Oakfield Lodge Residential Care (2019).

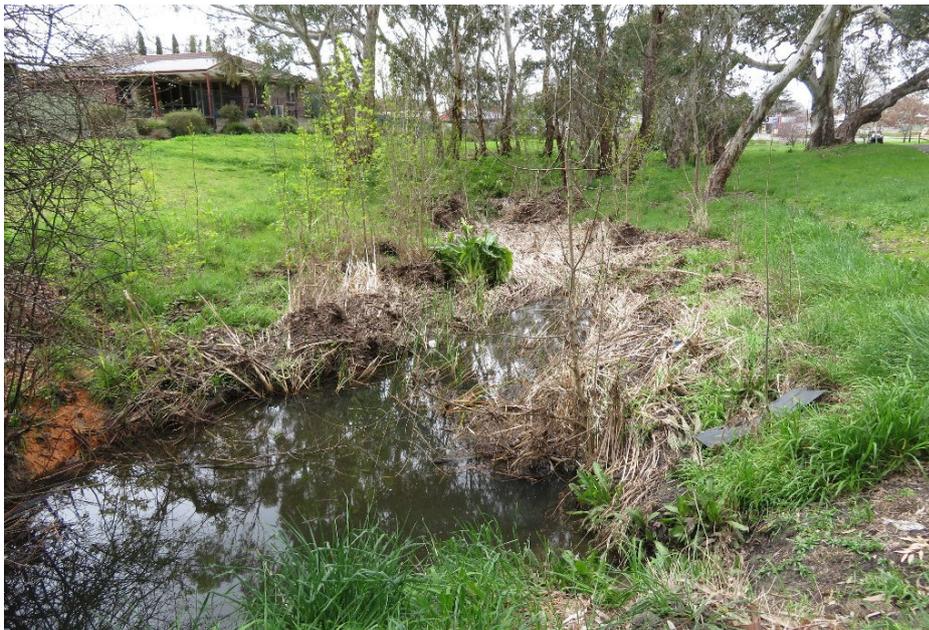
Downstream of the aged care facility the creek floods out and then reforms again north of Mount Barker Primary School. This section of creek is very weedy with Blackberry, Ivy, Desert Ash and wild plums. There is some erosion around the footbridge where overland run-off enters the creek, and bed deepening downstream of a small pond. There has been extensive revegetation of the adjacent Primary School land; restoring this section of creek could link to the existing revegetation.

Figure 4.31 Creek adjacent to Mount Barker Primary School revegetation block (2019); note abundant Ash saplings as well as other exotic trees and Arum Lily growing in creek.

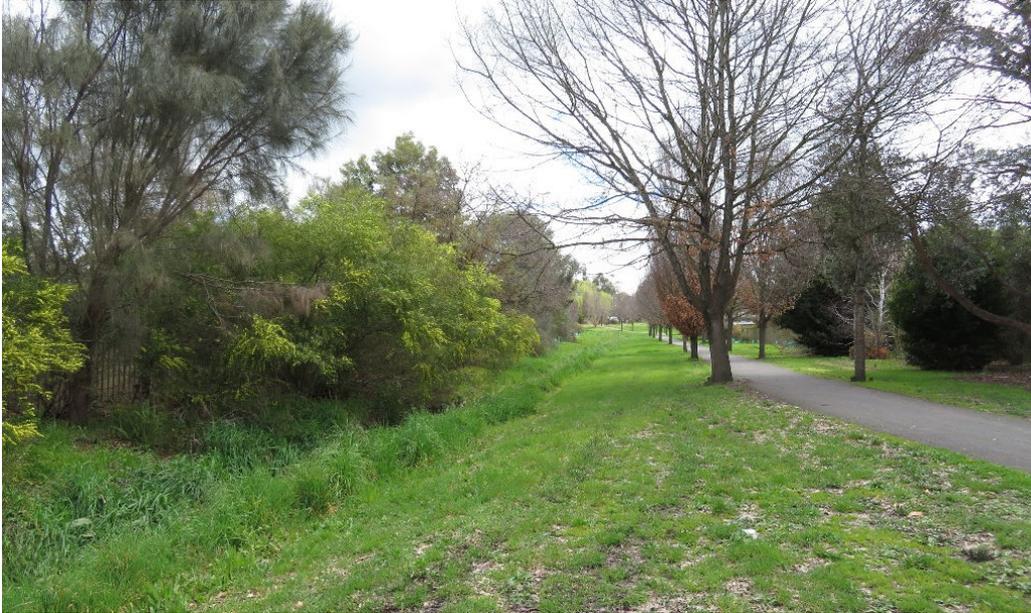
This section lacks large remnant trees but has several small areas of revegetation. A dam midway along the creek has abundant Bulrush. Several patches of Blackberry have been sprayed but there is some that is growing into the dam – it may be possible to control this patch if water levels drop over Summer but care will need to be taken to avoid off-target damage. There is some erosion immediately above and below the dam. The creek is probably entirely constructed for stormwater.

Figure 4.32 Drainage line upstream of Peake Court with revegetated native shrubs on the eastern bank (2019).

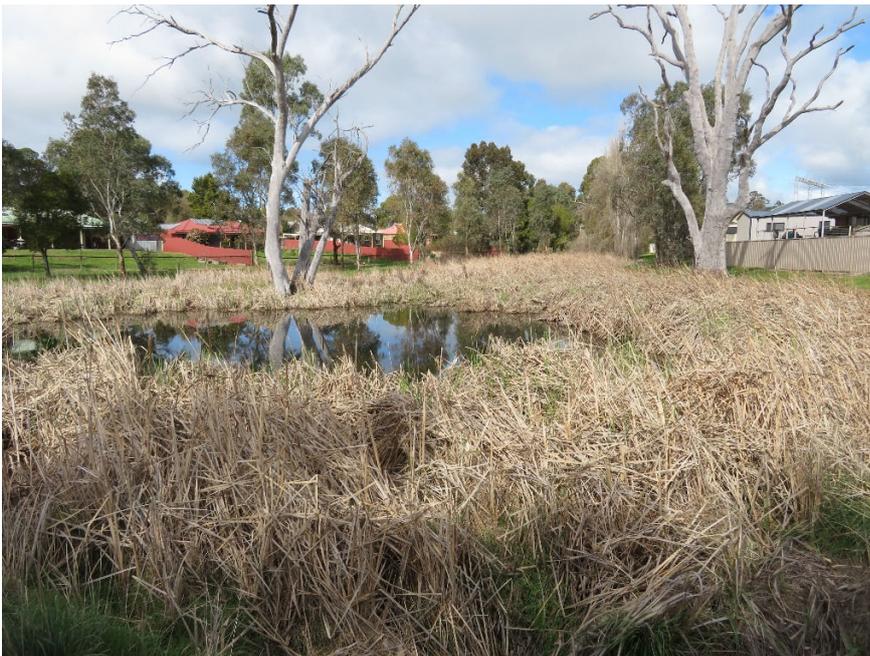
This short section of creek drains a salty sub-catchment. There are some large remnant, regenerated and planted River Red Gums as well as Bulrush growing in the creek and dam and planted Blackwoods. There is a large dam that pre-dates the housing development.

Figure 4.33 Dam in creek upstream of Flaxley Road (2019).

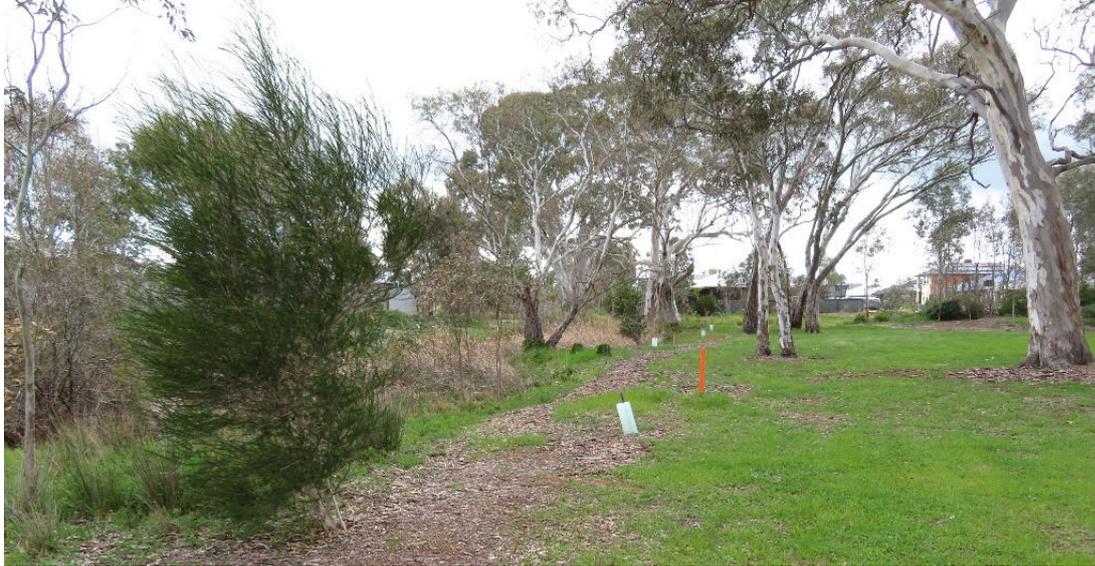
Upstream of Hurling Drive, Railway Creek has been revegetated with a mix of local and non-local Australian native species, including Bracelet Honey-myrtle which can become a weed. There are a small number of Desert Ash and Willows. There are scattered young and old River Red Gums throughout.

Figure 4.34 West bank of creek upstream of Hurling Drive with remnant River Red Gums and planted Bracelet Honey-myrtle (2019)

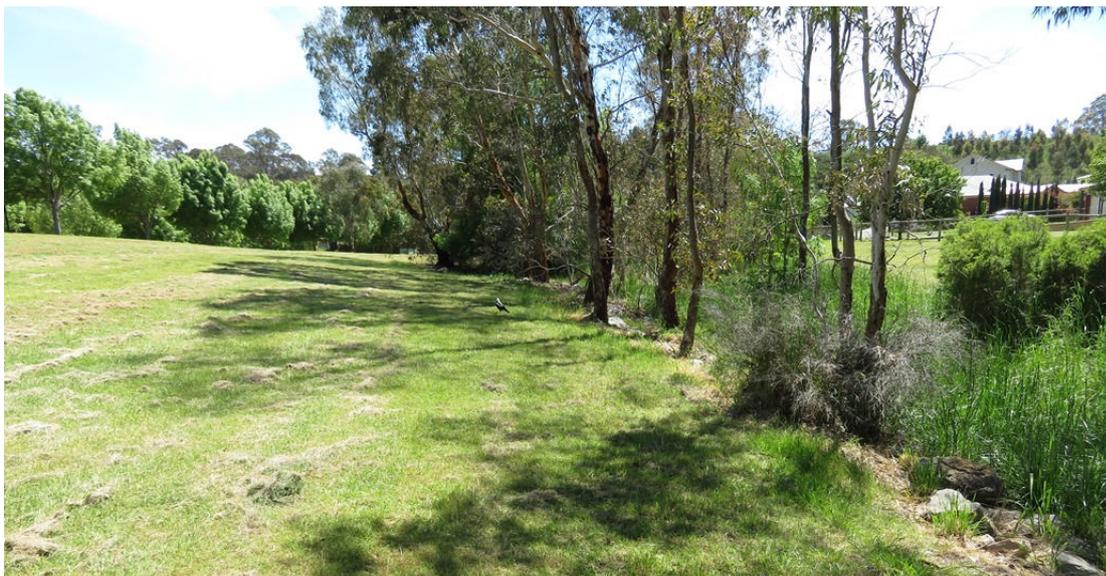
Creeks in the Waterford Estate are protected in wide riparian reserves and lined with remnant and regenerated River Red Gums with native sedges and rushes are present in the creek. The banks and adjacent riparian zone are lawned. Weed levels are generally low, but there is one occurrence of Drain Flat Sedge, some Blackberries and occasional Willows, Desert Ash and Box Elder saplings; the latter two species are probably sourced from street tree plantings. Pre-existing dams have been incorporated into the estate's stormwater management but have silted up. Rock riffles and bank battering have been used throughout to prevent erosion and there are some recently constructed ponds.

Figure 4.35 Creek in Waterford Estate with regenerated River Red Gums and Bulrush in the creek (2019).

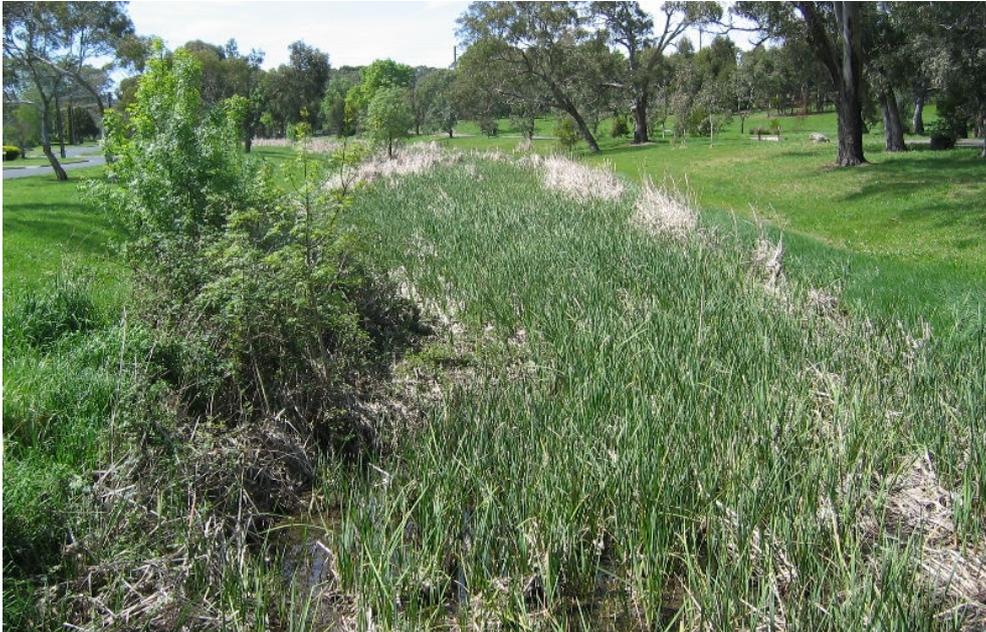
Figure 5.1 Western Flat Creek, looking downstream from Bollen Road bridge, photo taken in September 2006; note: open water visible between Bulrush stems.

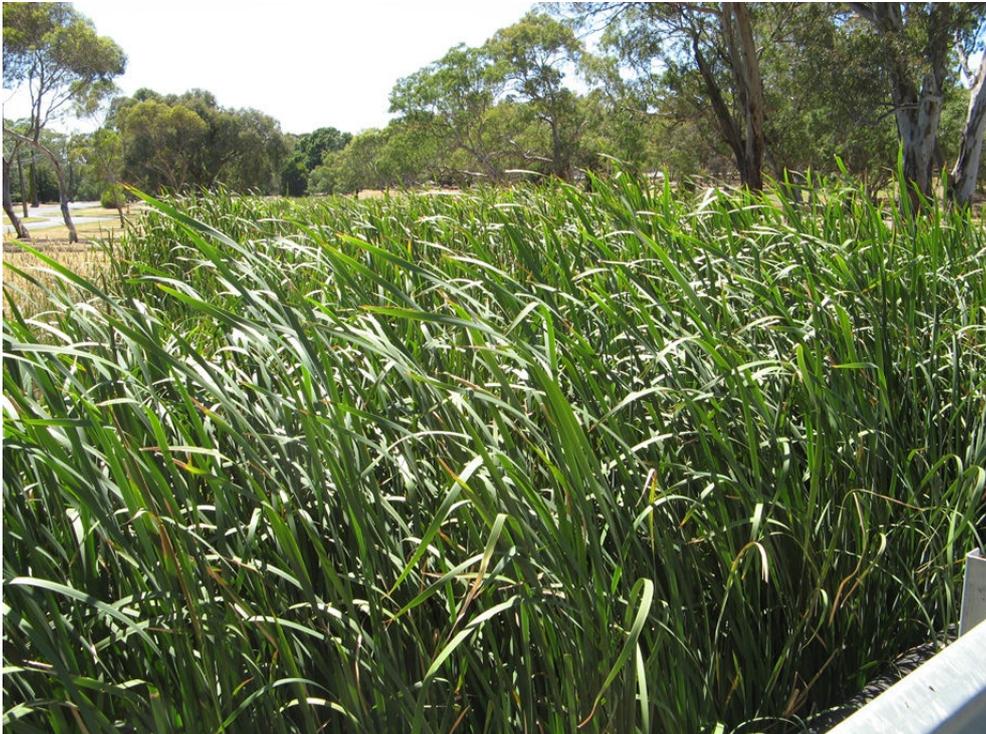
Figure 5.2 Same view as above in December 2012; note: increased density of Bulrush (larger size of plants is due to differences in time of year), lack of open water. The Ash Tree saplings to the left of the photo above have been removed.

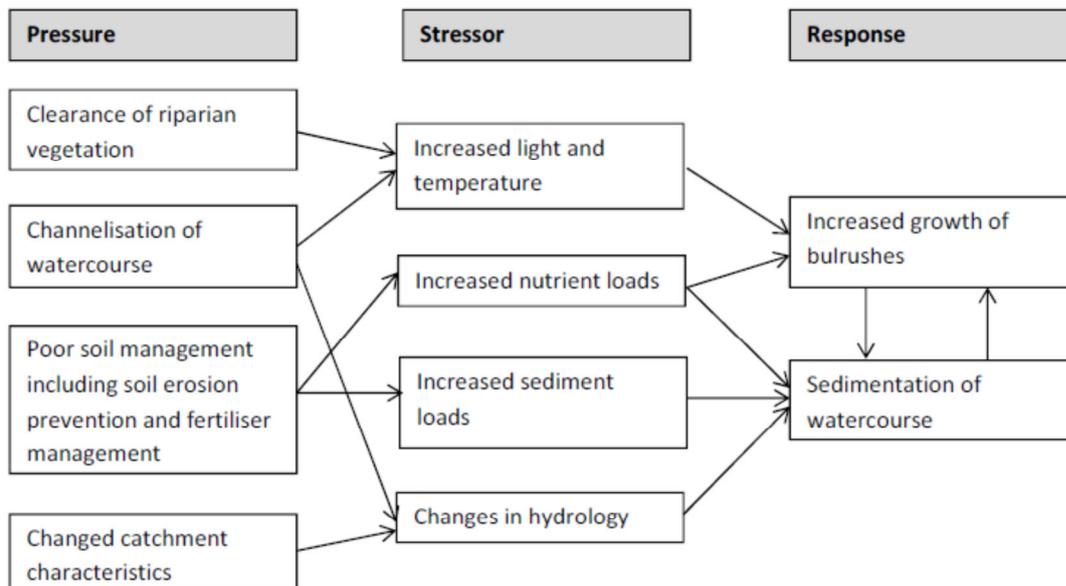
Figure 5.3 Pressure – stressor – response model showing likely causes of prolific Bulrush growth in Mt Barker Creek

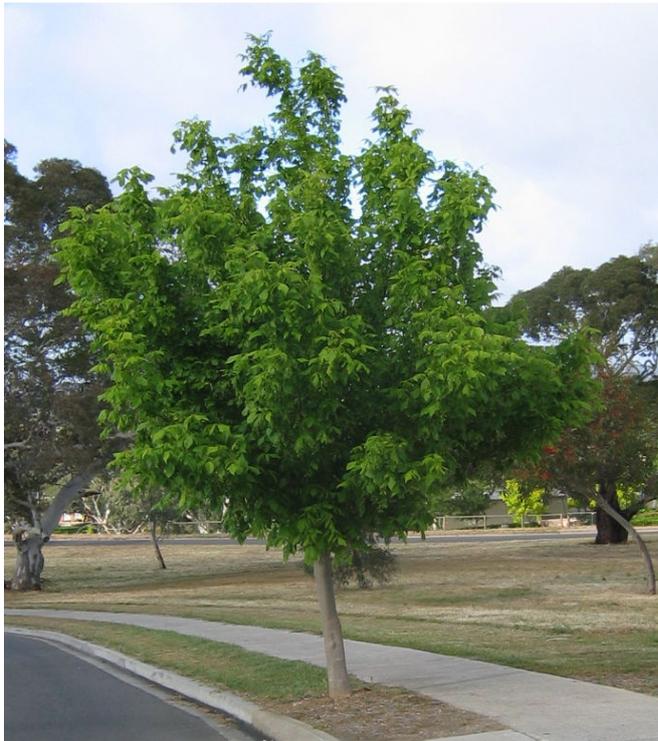
Figure 5.7 Box Elm is widely used in new development areas but has a high weed potential, producing numerous seedlings and thriving in damp situations

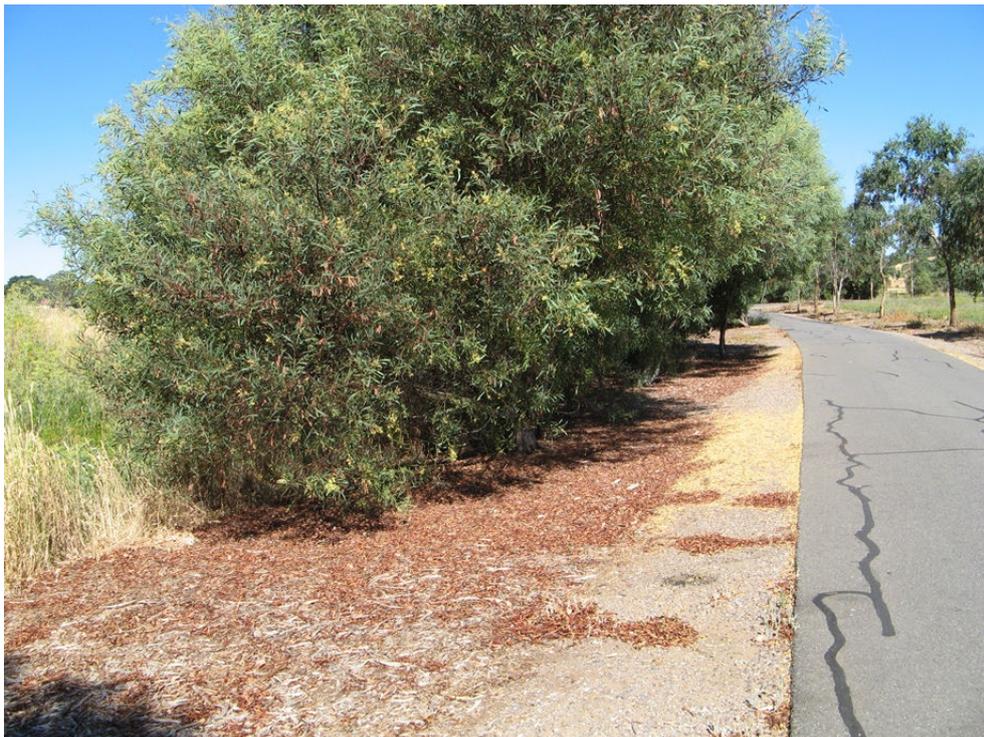
Figure 5.8 Revegetation dominated by Swamp Wattle and lacking understorey (2012)
